4.4. West Wing

6. Analysis of architectural features

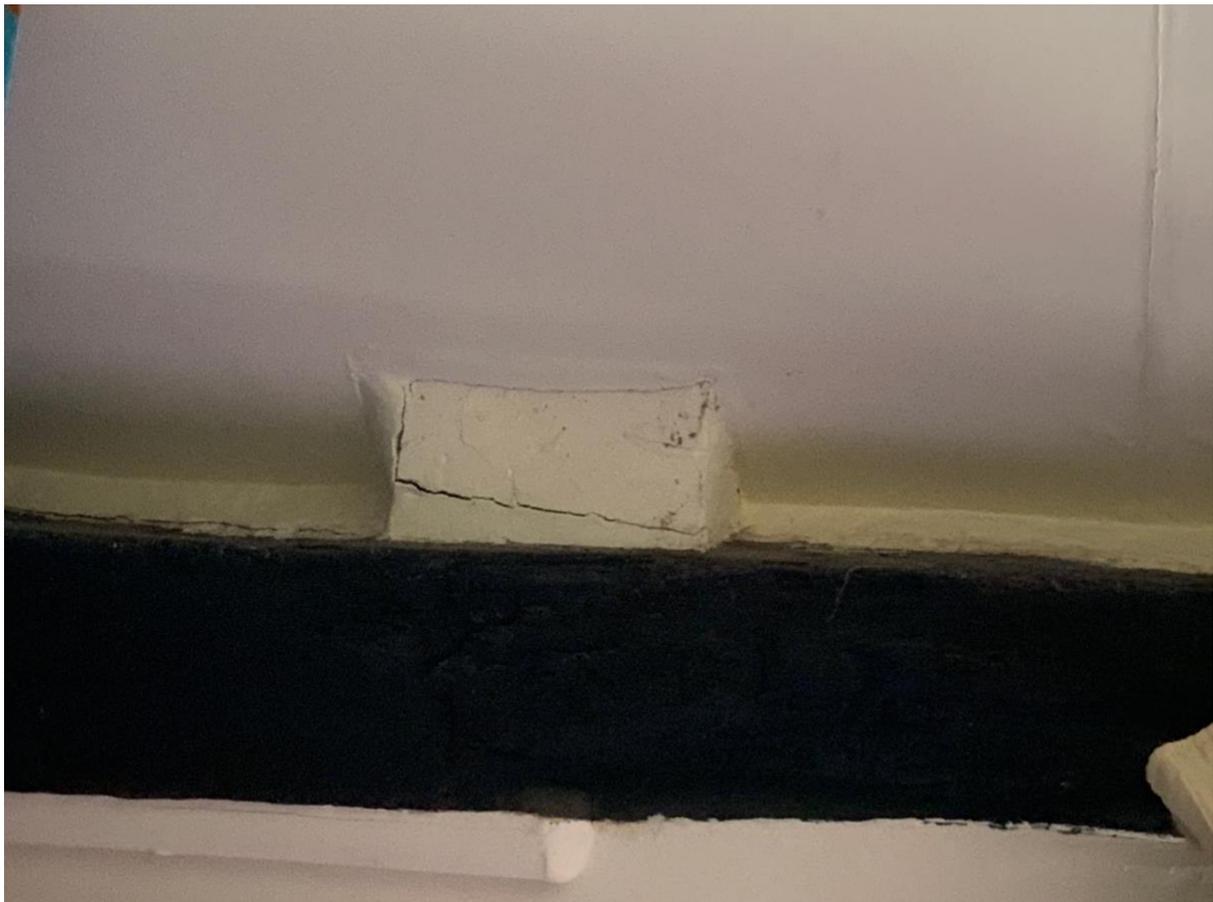
The East wall abuts to the main range where the wall-plates of the West wing lie over the wall plates of the main range. The end of the North wall plate is visible in the first-floor bedroom within bay II of the main range. (see Figure 2).

Figure 2, End of the West wings - North Wallplate. (Author 2019).

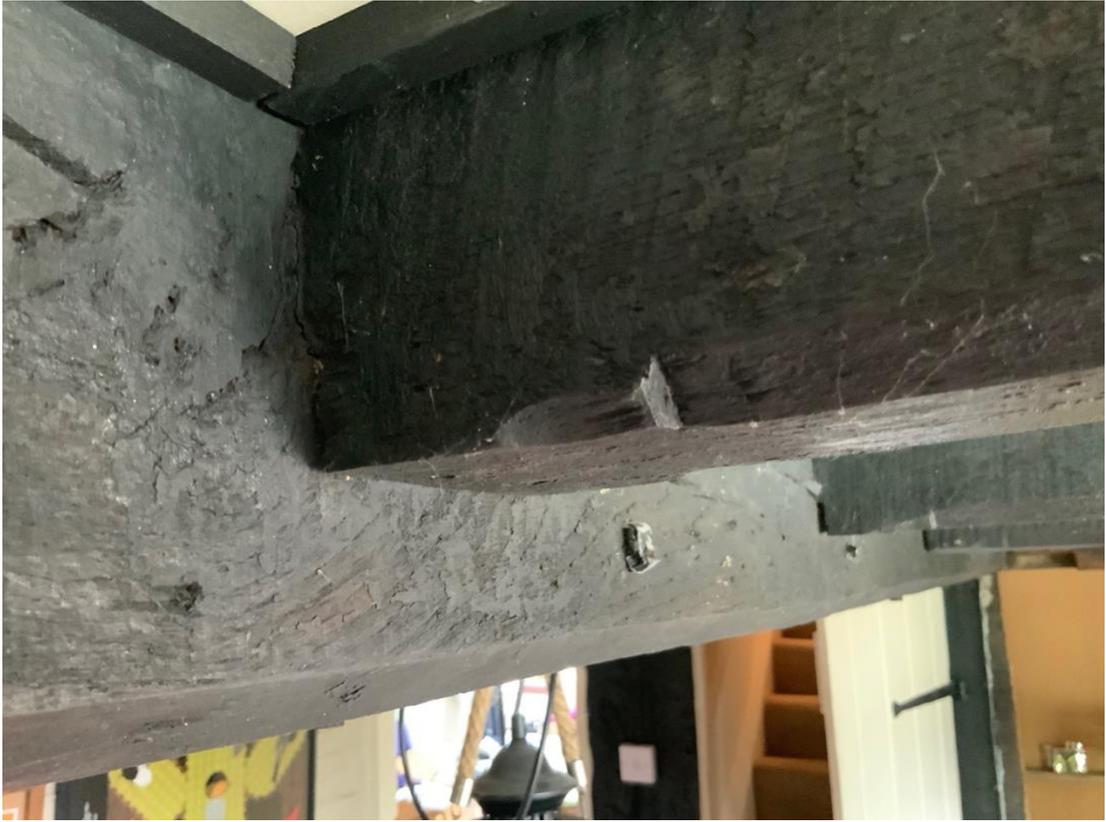
The joists and spine beam are mostly chamfered with lambs tongue chamfer stops

Figure 3, Showing "Lamb's Tongue" chamfer stops on joists. (by Author 2019).

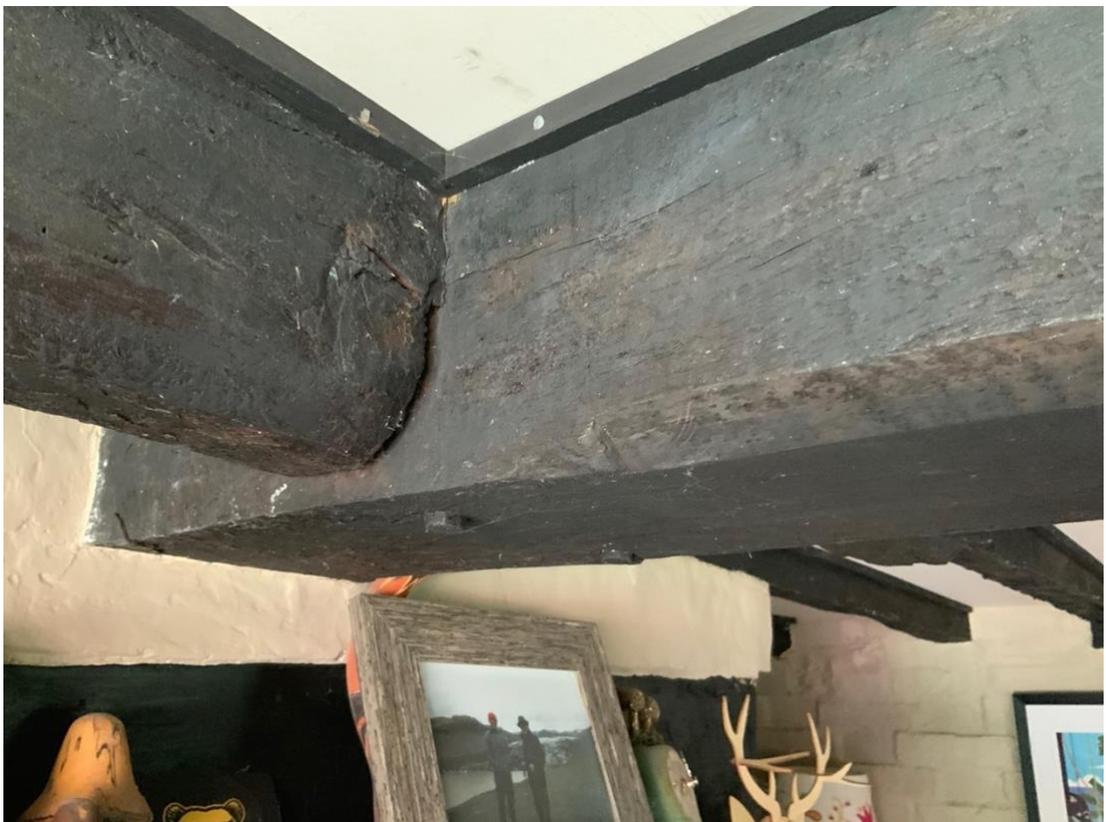
Figure 4, Showing chamfer stops on the spine beam (by Author 2019).

The chamfer stops on the spine beam stop short of the chimney breast which is consistent with them being contemporary.

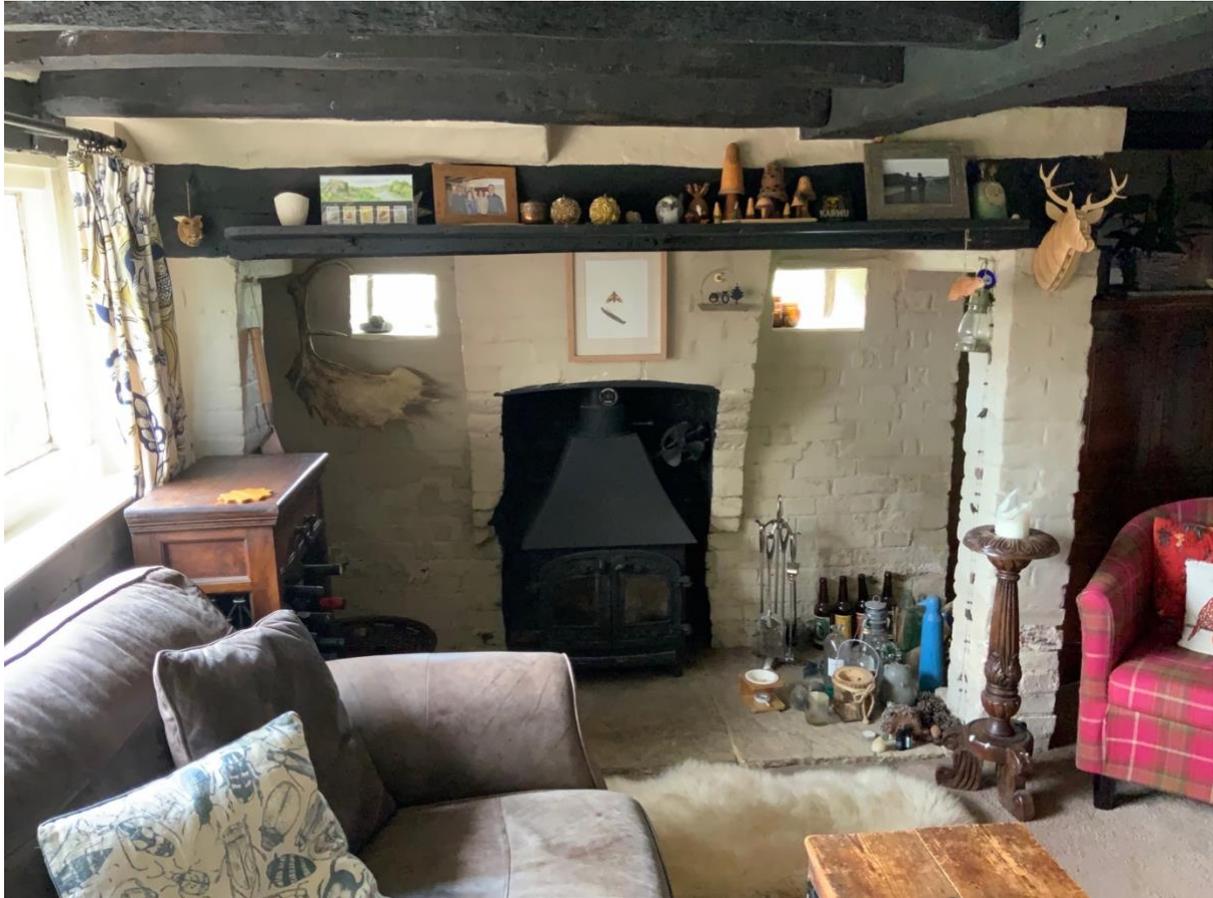
Figure 5, Looking west towards the hearth in the West wing. (Author 2019).

Similar to the hearth in the North of the Main range the chimney is presently supported on brick piers. The bricks of which are different in size to those in the wall that makes up the chimney. Additionally, a brick hood has been created which currently accommodates a cast iron stove. The hearth area has been covered with modern stone slabs.

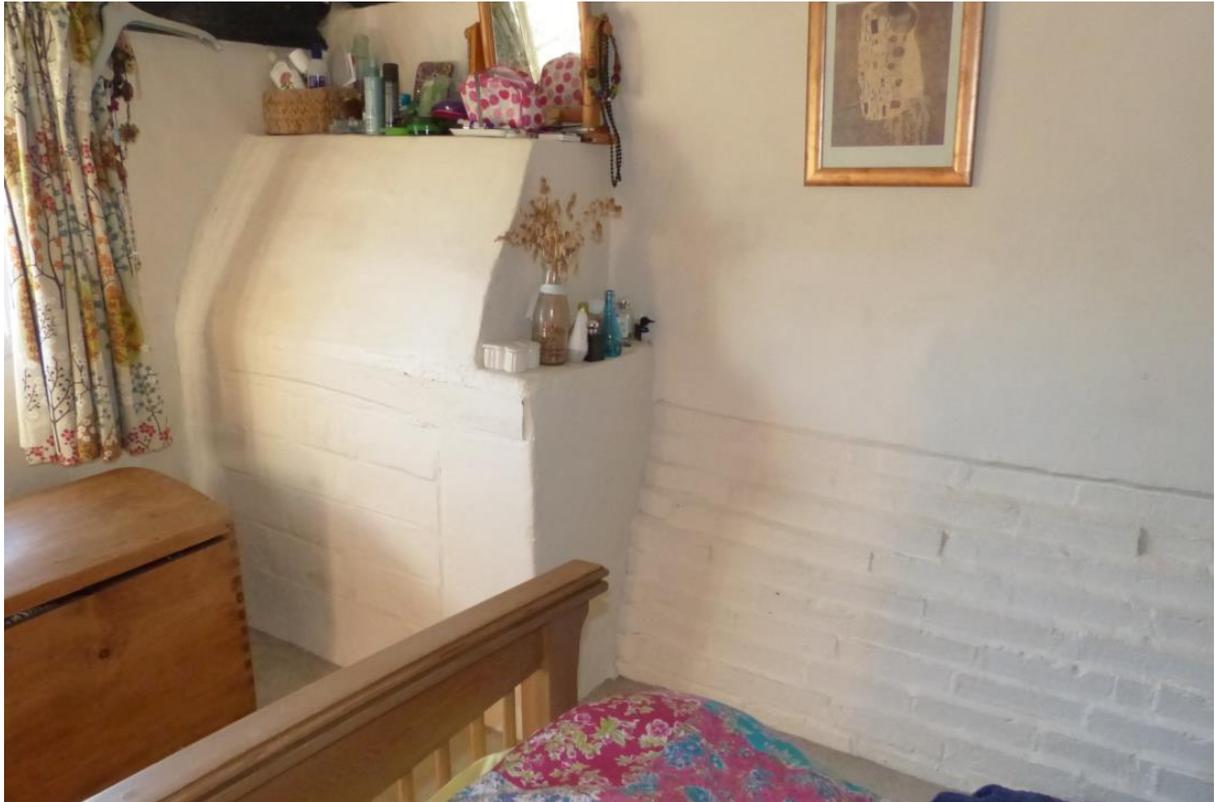
The first-floor hearth forms a box like structure that protrudes from the chimney stack by about 18" (500mm). I suspect that this is a later addition and has been created this way to give sufficient space for the hearth to be accommodated in front of the existing chimney stack and still be able to control the smoke. The hearth opening has been bricked up in 'rowlock' bricks (Figure 6).

Figure 6, West Wing First Floor hearth. (Dave Green 2019).

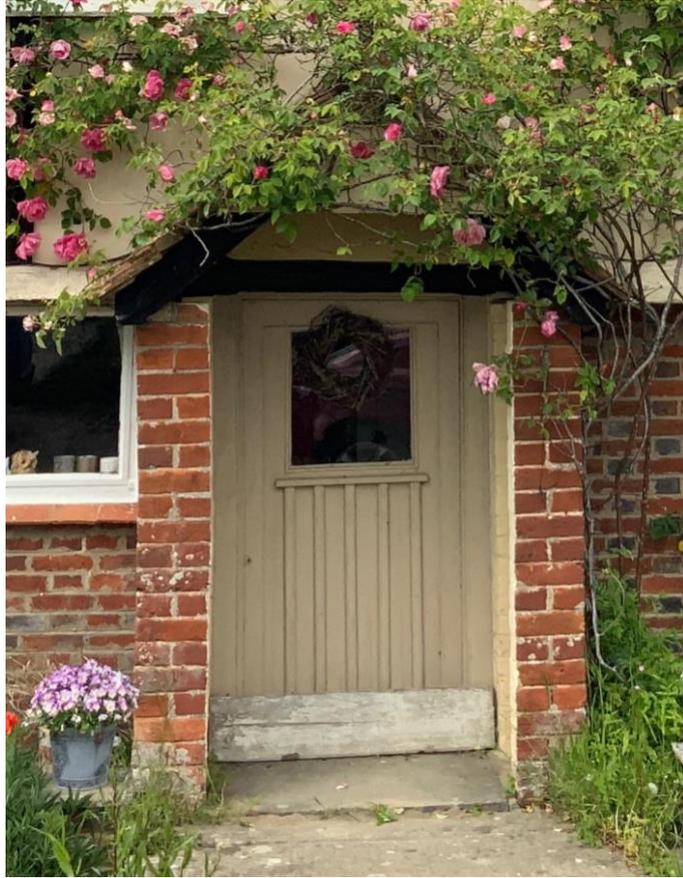
This is clearly a doorway that was created contemporaneously with the brick facia, and now contains a painted partially glazed timber door.

Figure 7, Front door in south elevation of West wing (Author 2019).

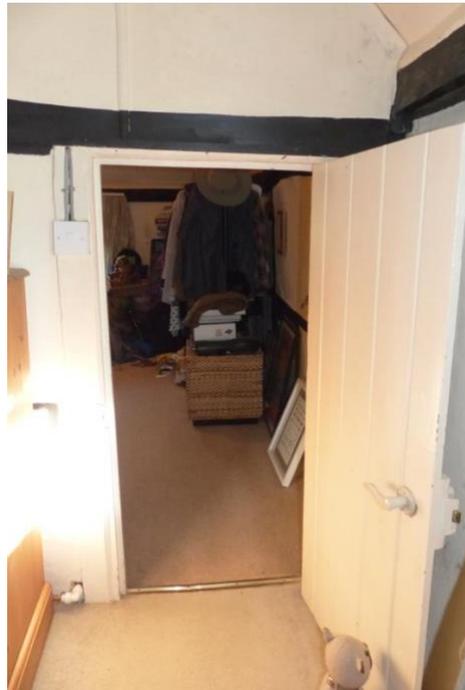
Figure 8, Bedroom door. (Dave Green 2019).

A painted plank door with modern door furniture.

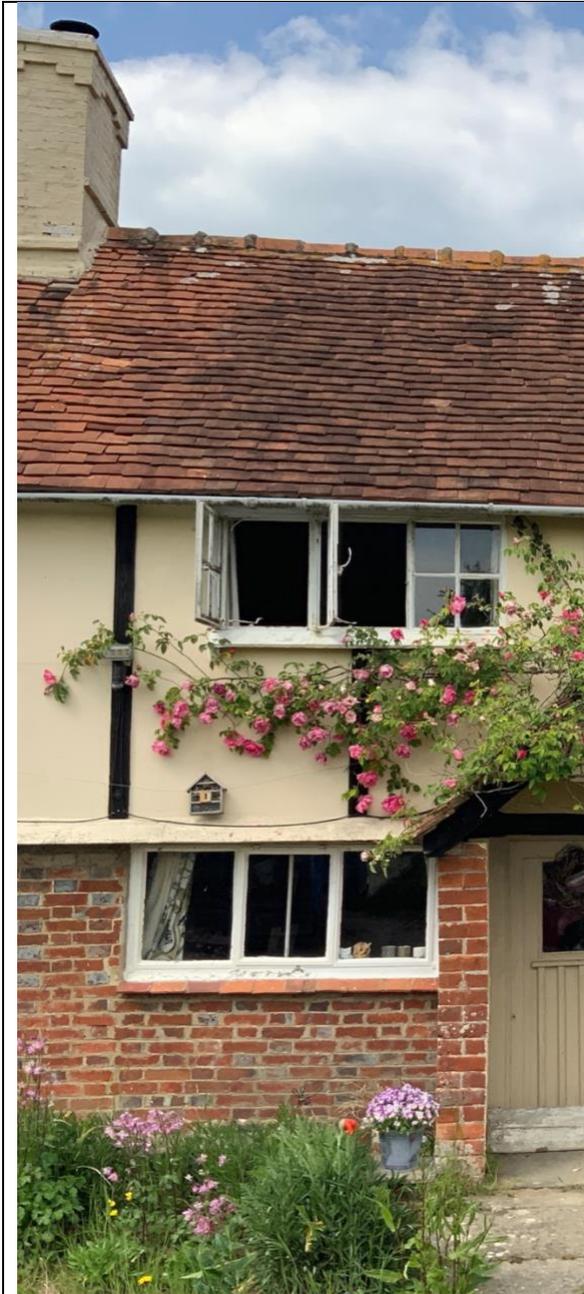
There are only two windows in the West wing. Both appear to be hardwood casements with 'crittall' sashes. The window apertures appear to be similar in position and size to those present in the 1937 photographs supplied, but the sashes have been replaced.

Figure 9, Present day windows (by Author 2019).

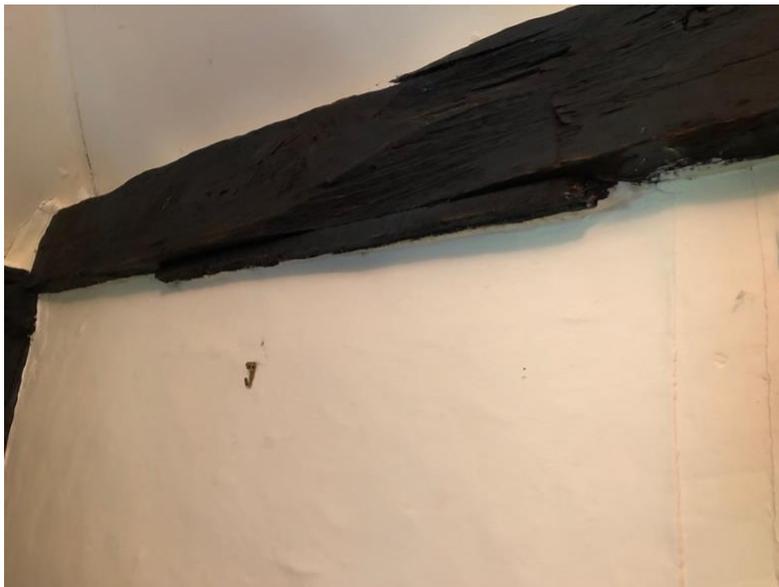
Figure 13, Possible Shutter runner in South elevation, (Author 2019)

Without further invasive investigation it is not possible to determine location and sizes of the original windows. However, there is some evidence for a window in the South elevation of the main range in that there appears to be a surface planted timber on the soffit of the tie beam that may be connected with a shutter runner.

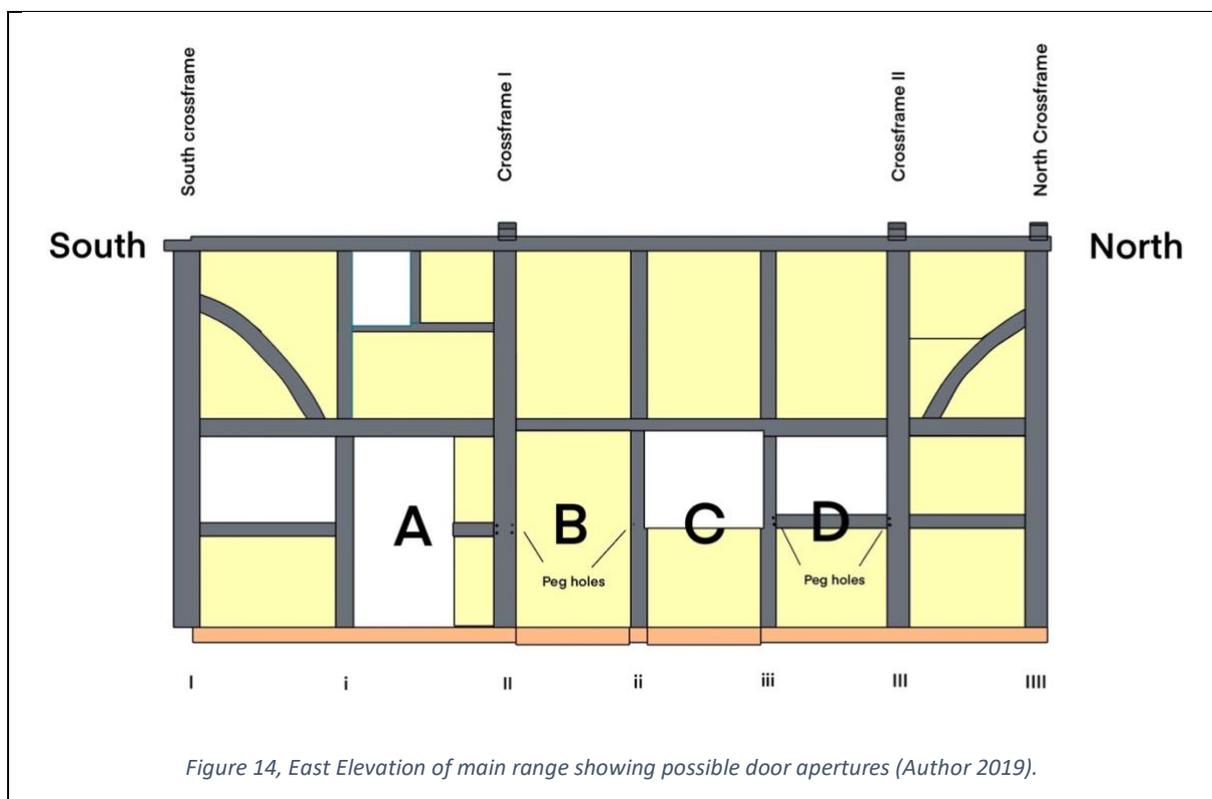
To the North of the existing doorway [A] in the East elevation exists a truncated rail with pegs at its connection with the 'Story post [II]. Additionally, there are peg holes to the stud to the South [I] suggesting that there once existed a rail across this panel and the likelihood that [A] is a later created doorway.

There are also existing peg holes created in the story post [II] and stud [ii] which indicate that a rail once existed across [B] negating the possibility of an original door way here. The studs [iii] and [iii] have been reduced across their width removing the portion of timber that might have contained evidence of pegs indicating a rail across [C] however, the bressummer is reduced in width here, and where the stud [ii] connects to the soffit of this bressummer which would be consistent with it being of this form from its date of construction. This would indicate the possibility of either a window or doorway at [B] or [C]. In addition, the presence of a brick step and both [B] and [C] or widened plinth could add weight to this possibility. However, we cannot be certain when the brick plinth was constructed or that it was ever used as a doorway as there is no apparent wear to the bricks.

It is by no means certain that a doorway existed in the East elevation. but if did, its most likely location would therefore be at [C] with possibly a window at [B].

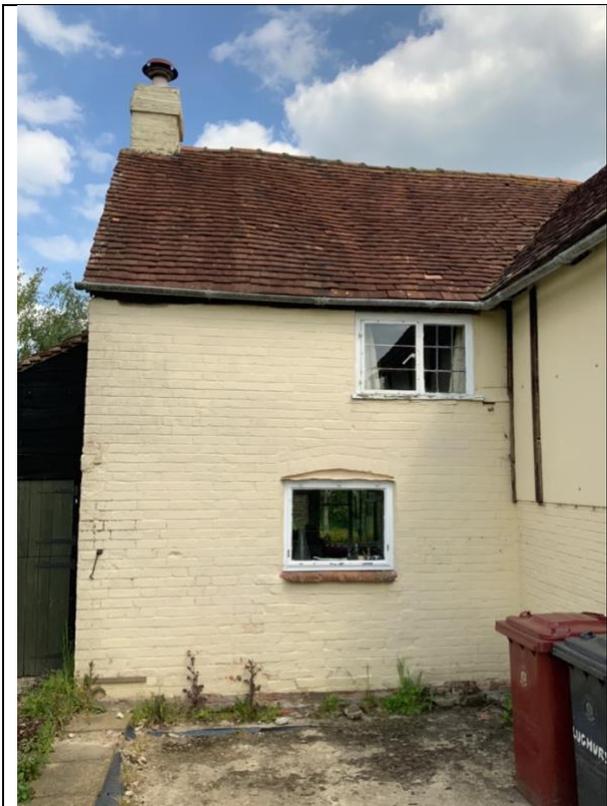
Of note is that the brickwork in the North end of the West elevation of the main range is different; being a slightly larger brick and possibly the same as the bricks forming the piers supporting both the North chimney and West chimney. It may be the case that this wall was replaced in brick some time later possibly when the brick work was done above the tiebeam in the North.

The brickwork at the North end of the West wall of main range appears to be keyed in around the stone suggesting the stone work existed prior to the brickwork.

Figure 16, West Elevation of main range. Author 2019.

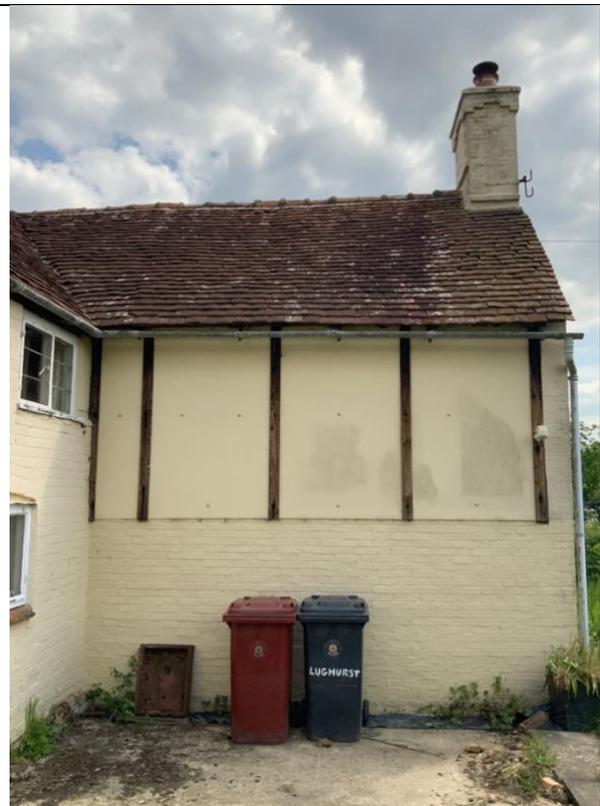
Figure 17, North Elevation of West wing, Author 2019.

The proposed extension would I understand re-instate the area previously infilled by the shop/ Sub Post office in the North West corner and would visually impact on the North elevation of the West Wing and West Elevation of the main range.
