8.0. Conclusion and statement of historical significance

Site name: Lughurst Burdocks

Type of report: Historic Significance Assessment

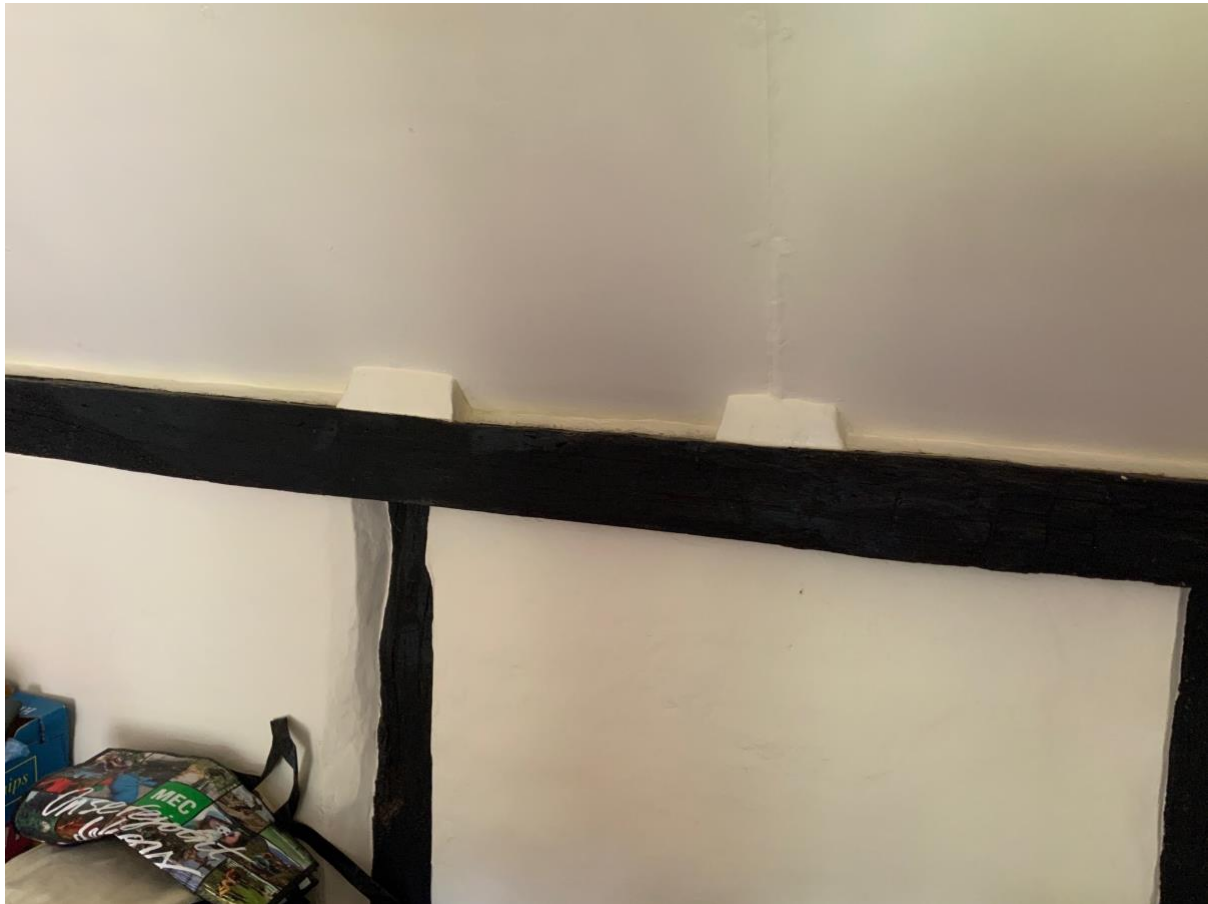
Figure 7, unusual plaster lumps.

Although by no means certain, these unusual 'lumps' in the plasterwork sitting on the top of the wall plate are possibly a way of supporting rafters where the connection has decayed either in the wall plate or the rafter itself.

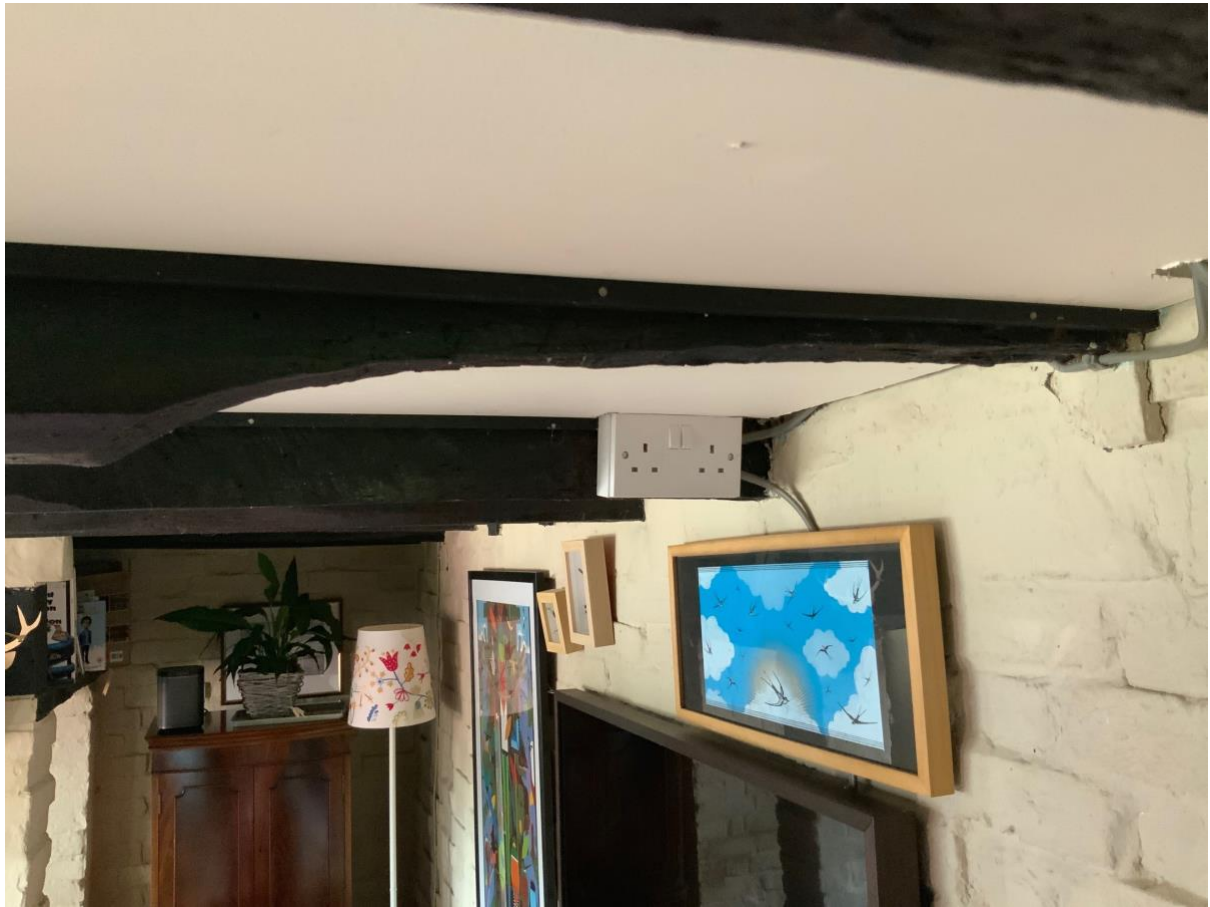
Figure 15, Joists cut away to accommodate a tall piece of furniture.

Some joists in the West wing have been cut away against the North Wall. This is often found when large pieces of furniture have previously been located here.

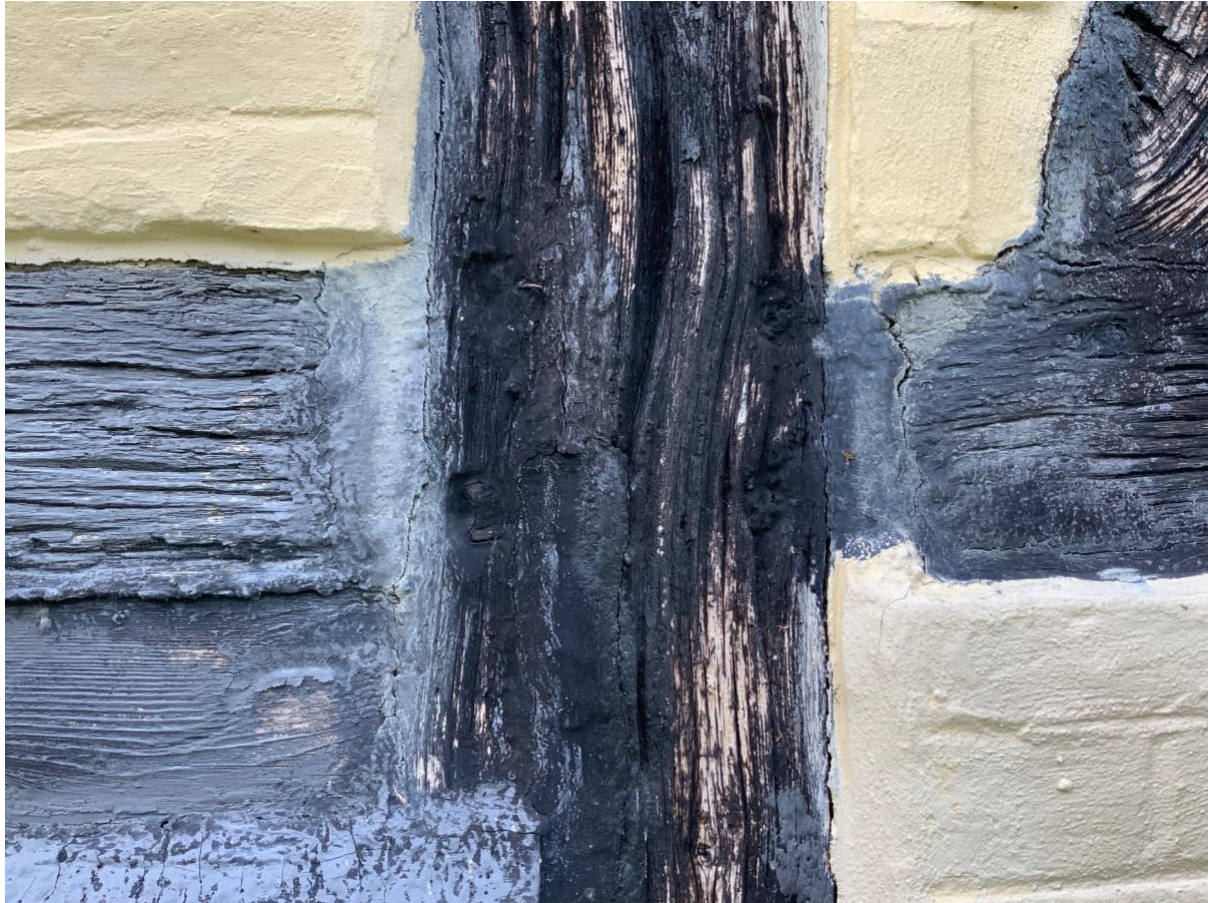
Figure 16, impervious paints and filled joints.

In the above image we can see two issues.

1. The timbers are covered in impervious paint. These paints have been applied with good intent, believing that the paint will enhance the appearance of the building and prevent the ingress of moisture. However, due to the nature of timber it will constantly move, creating gaps where water will gain access. The impervious paint then acts to prevent natural evaporation of the water, raising the moisture content of the timber. When the moisture content of the timber increases above 17.5 % agents of decay can survive and at 21% will thrive. The result is that the timber decays at an accelerating rate, leading to the loss of historic fabric, deterioration of neighbouring fabrics, greater moisture ingress and eventually structural incompetency.

2. As timber dries it shrinks. Over time this shrinkage forms gaps in the joints between connecting timbers. Movement in other parts of a frame may also cause gaps in joints. It is tempting to fill these gaps with impervious fillers such as cement to prevent water ingress. However, like the application of paint, these fillers do not prevent water ingress but do prevent natural evaporation which leads to decay.

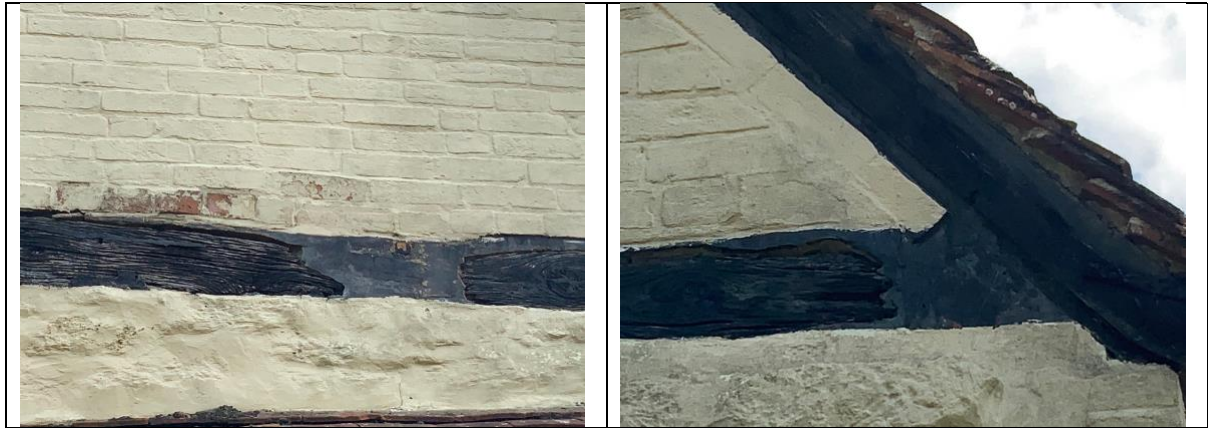
Figure 17, an area of decay filled with cement.

The timber in the image above is a tie beam. Tiebeams are vital structural timbers. They resist forces from the roof that are trying to spread the roof at the eaves. i.e. the tiebeam is in 'tension'. Filling decayed areas in this timber with an impervious material such as cement will hide the fact that the timber has been compromised and will accelerate the decay process for all the reasons described above. Failed or cut tiebeams can lead to catastrophic deformation of the building.

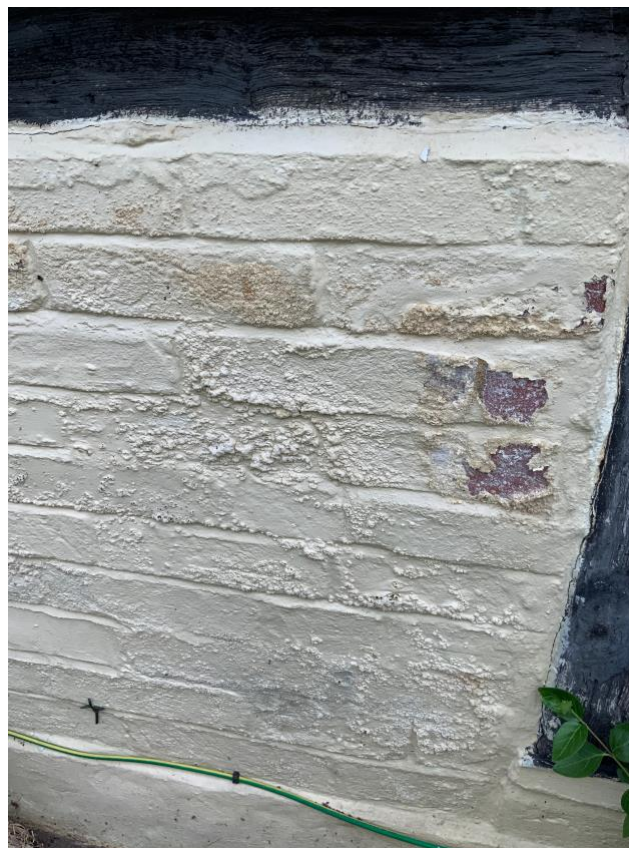
Figure 18, Blistering impervious paint.

Paints are applied to historic building for two reasons; firstly, as decoration to change the appearance or to hide defects. However, the result in buildings that do not contain a damp-proof course (anything before about 1875) will be that the paint will blister. This is because moisture in these buildings is always present to some degree. It is almost impossible to prevent this, but, it does not mean that the building has to be damp or unsightly. When they were built, these impervious materials did not exist. The moisture evaporated away by the action of the sun, heat and passage of air. The application of impervious paints prevents this natural occurrence, trapping the water in the building. In a very short amount of time, the water forces its way through the impervious layer creating blisters and loss of paint.
