Historic Significance assessment;

The loft in the lean-to in the West wing

Black House Farm
Hinton Ampner
Hampshire
SO24 0LF

10th May 2018

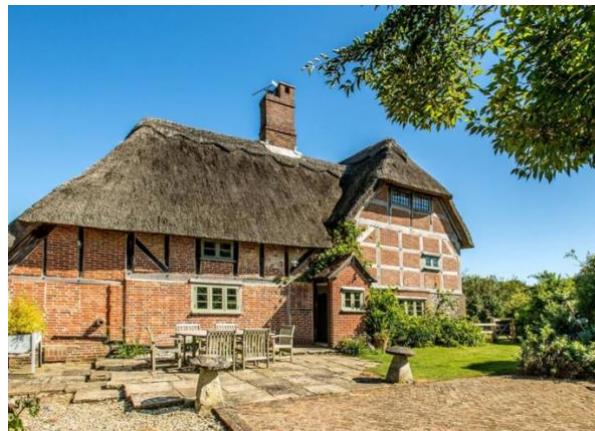
Figure 6, Black House Farm House.

Research by the DBRG, historical records and architectural styling would suggest that the farm house dates from the early C17th. It appears to have initially been built as a single range of 2 bays in small panel framing. Later a cross wing of one bay plus outshot was added.

The lower parts of the timber frame have at some time decayed and been replaced with brick in the cross wing and underbuilt or encased in brick and flint in the main range.

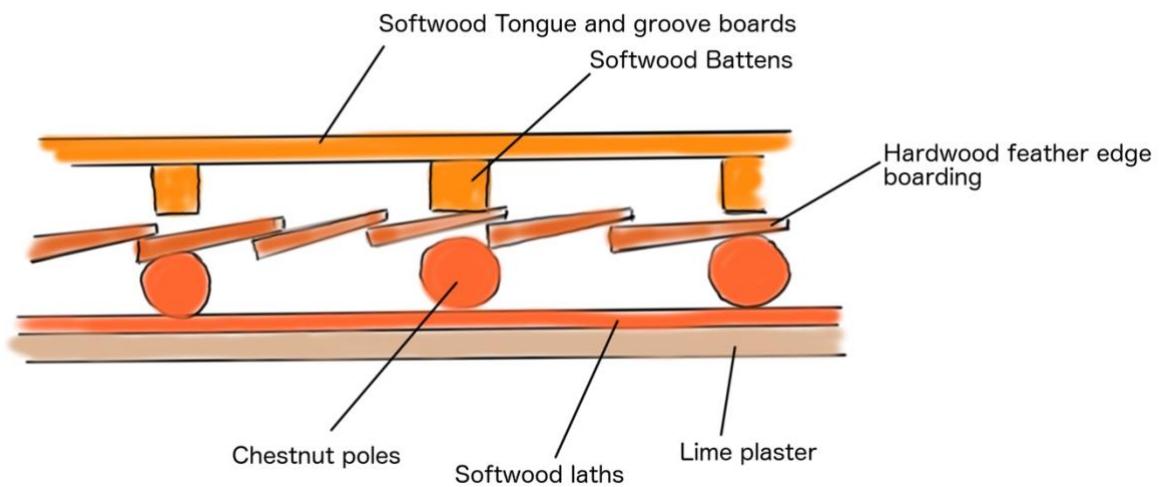
Figure 9, Enlarged section of floor make-up.

- 3, The door to the loft appears of 19c origin, but that could have come from anywhere and been done at any time.
- 4, The poles have been overlaid with weatherboarding. (Probably oak).
- 5, The weatherboarding has been floored over in very recent years with modern softwood.
- 6, The soffit of the chestnut poles has been lathed with softwood laths and lime plastered.

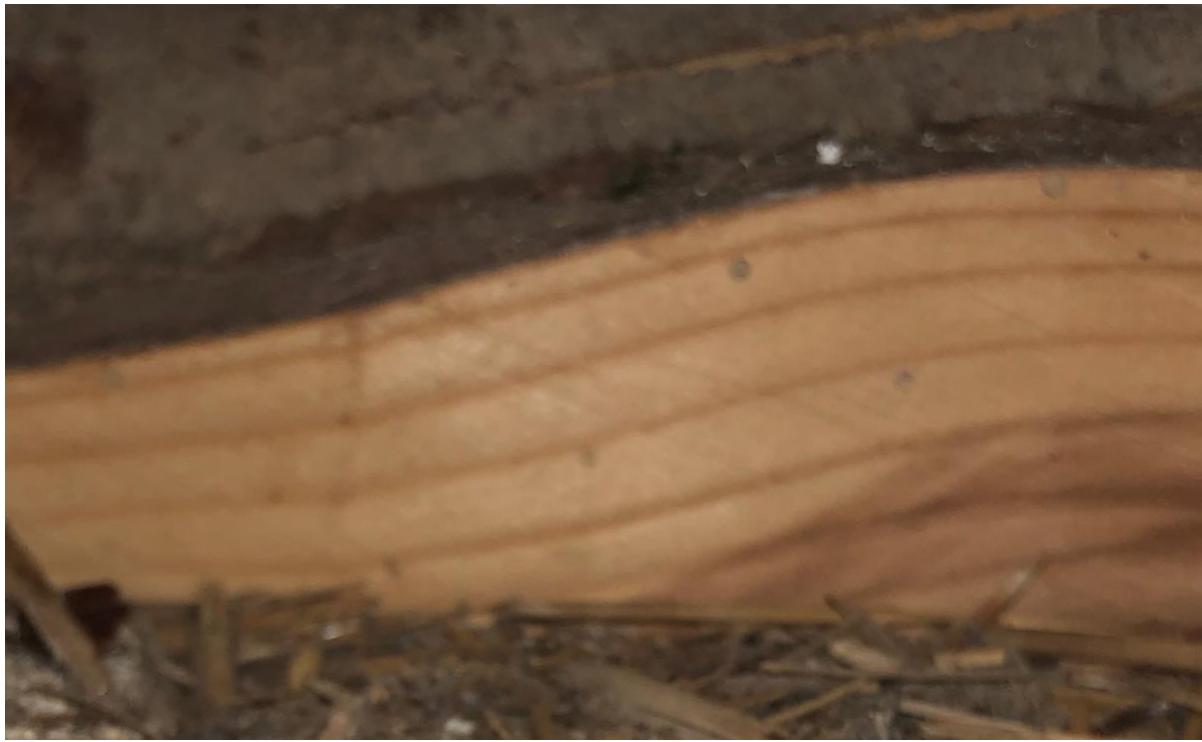
Figure 10, Chestnut Poles.

1, The main joists are Chestnut poles which have been incorporated into low status buildings, outbuildings or out-shots, such as this for many centuries. However, as the bark loosens with age and they still have very firmly connected bark, it would suggest that they are not very old.

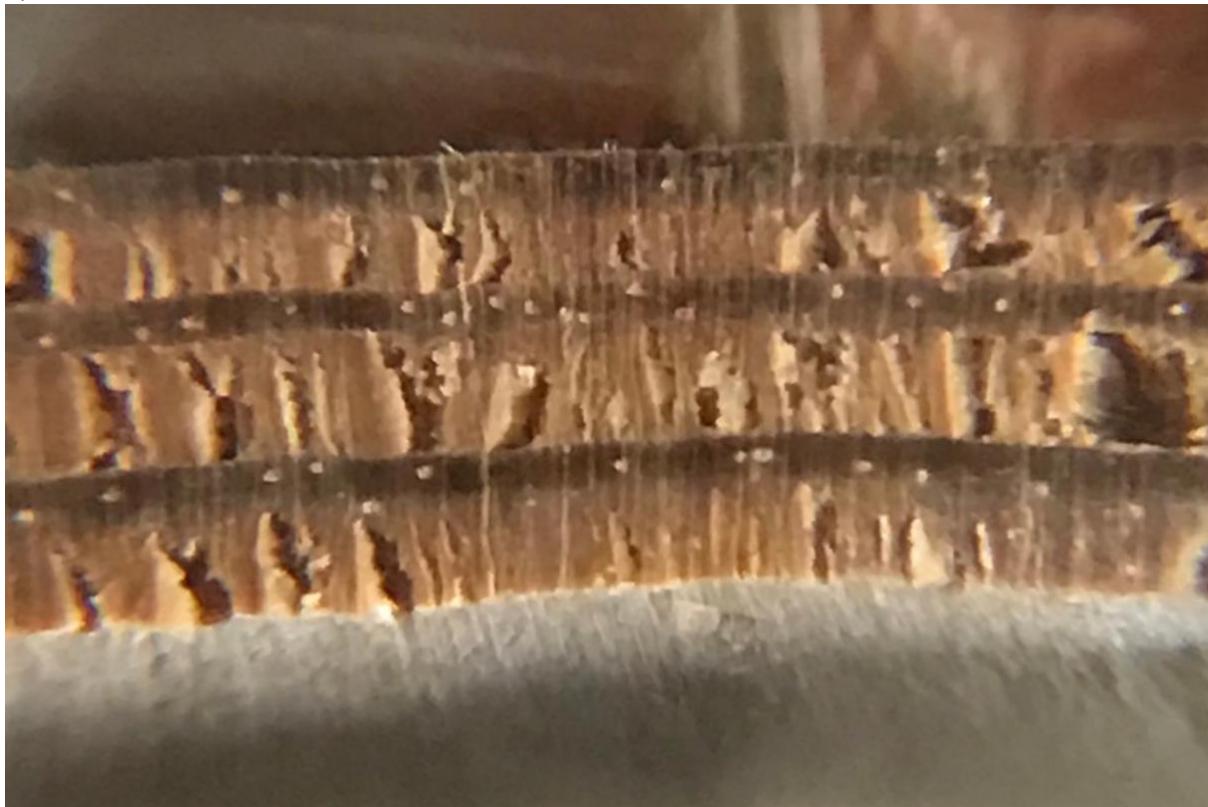
Figure 11, Softwood laths (end grain).

2, The laths are of softwood which became the norm in the 19c
