4.4. West Wing

6. Analysis of architectural features

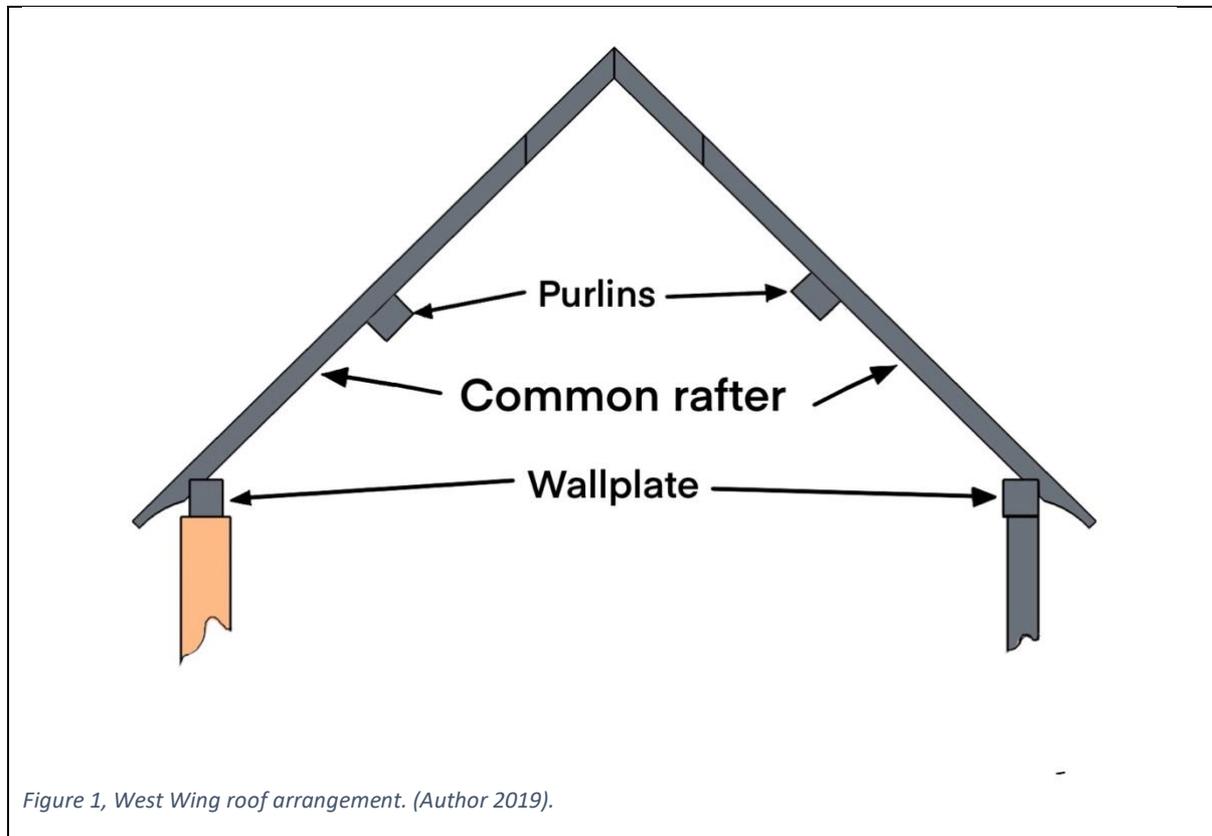
The roof of the West wing differs from that of the main range, in that it is essentially a common rafter roof with purlins.

A solitary tiebeam exists just in front of the chimney breast which forms no part of a truss arrangement. The base of the common rafters sits directly onto the wallplate and loadings from the roof are transferred through the purlin to the gable end and onto the main range roof and the through the wall plates onto the walls below.

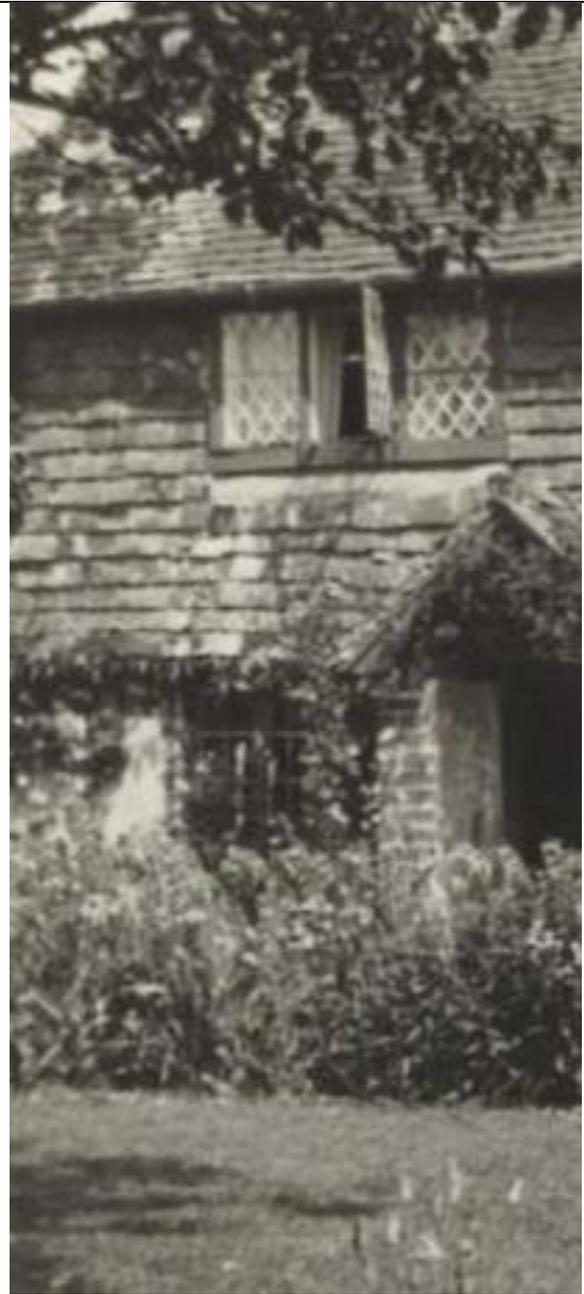
Figure 10, 1937 Photograph of the same windows.

There are only two windows in the West wing. Both appear to be hardwood casements with 'crittall' sashes. The window apertures appear to be similar in position and size to those present in the 1937 photographs supplied, but the sashes have been replaced.

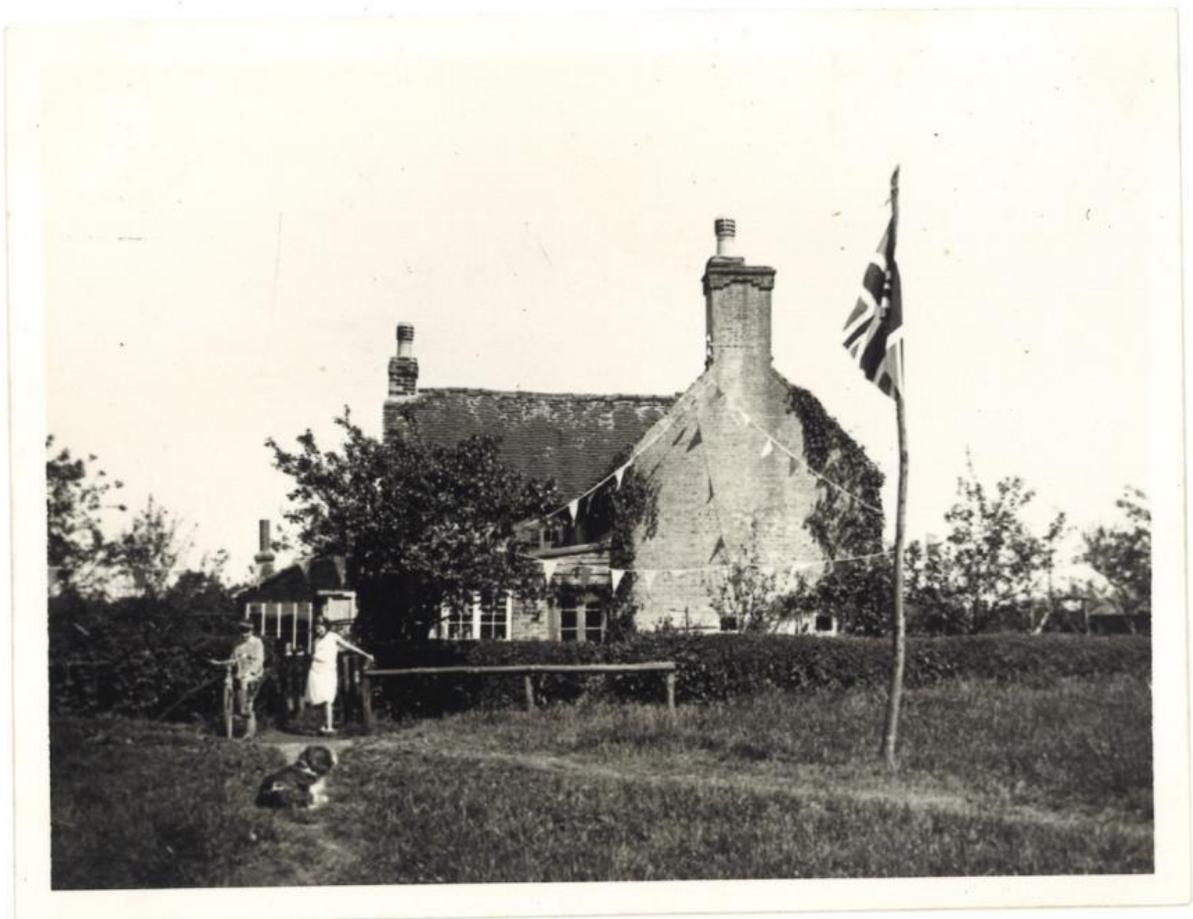
Figure 11, 1937 photo showing North East infill building.

Local verbal accounts and the image above demonstrate that at one time the area in the North West corner was once a single-story brick-built infill building with a lean-to roof. This building apparently formed the shop and Post office.
