8.0. Conclusion and statement of historical significance

Site name: Lughurst Burdocks

Type of report: Historic Significance Assessment

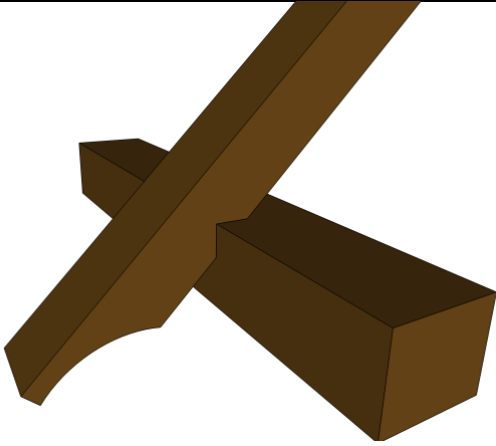
Figure 8, As built arrangement of rafter and wallplate.

Although by no means certain, these unusual 'lumps' in the plasterwork sitting on the top of the wall plate are possibly a way of supporting rafters where the connection has decayed either in the wall plate or the rafter itself.

As described below, a wedge of timber is created and placed on top of the wall plate and connecting with the soffit of the rafter.

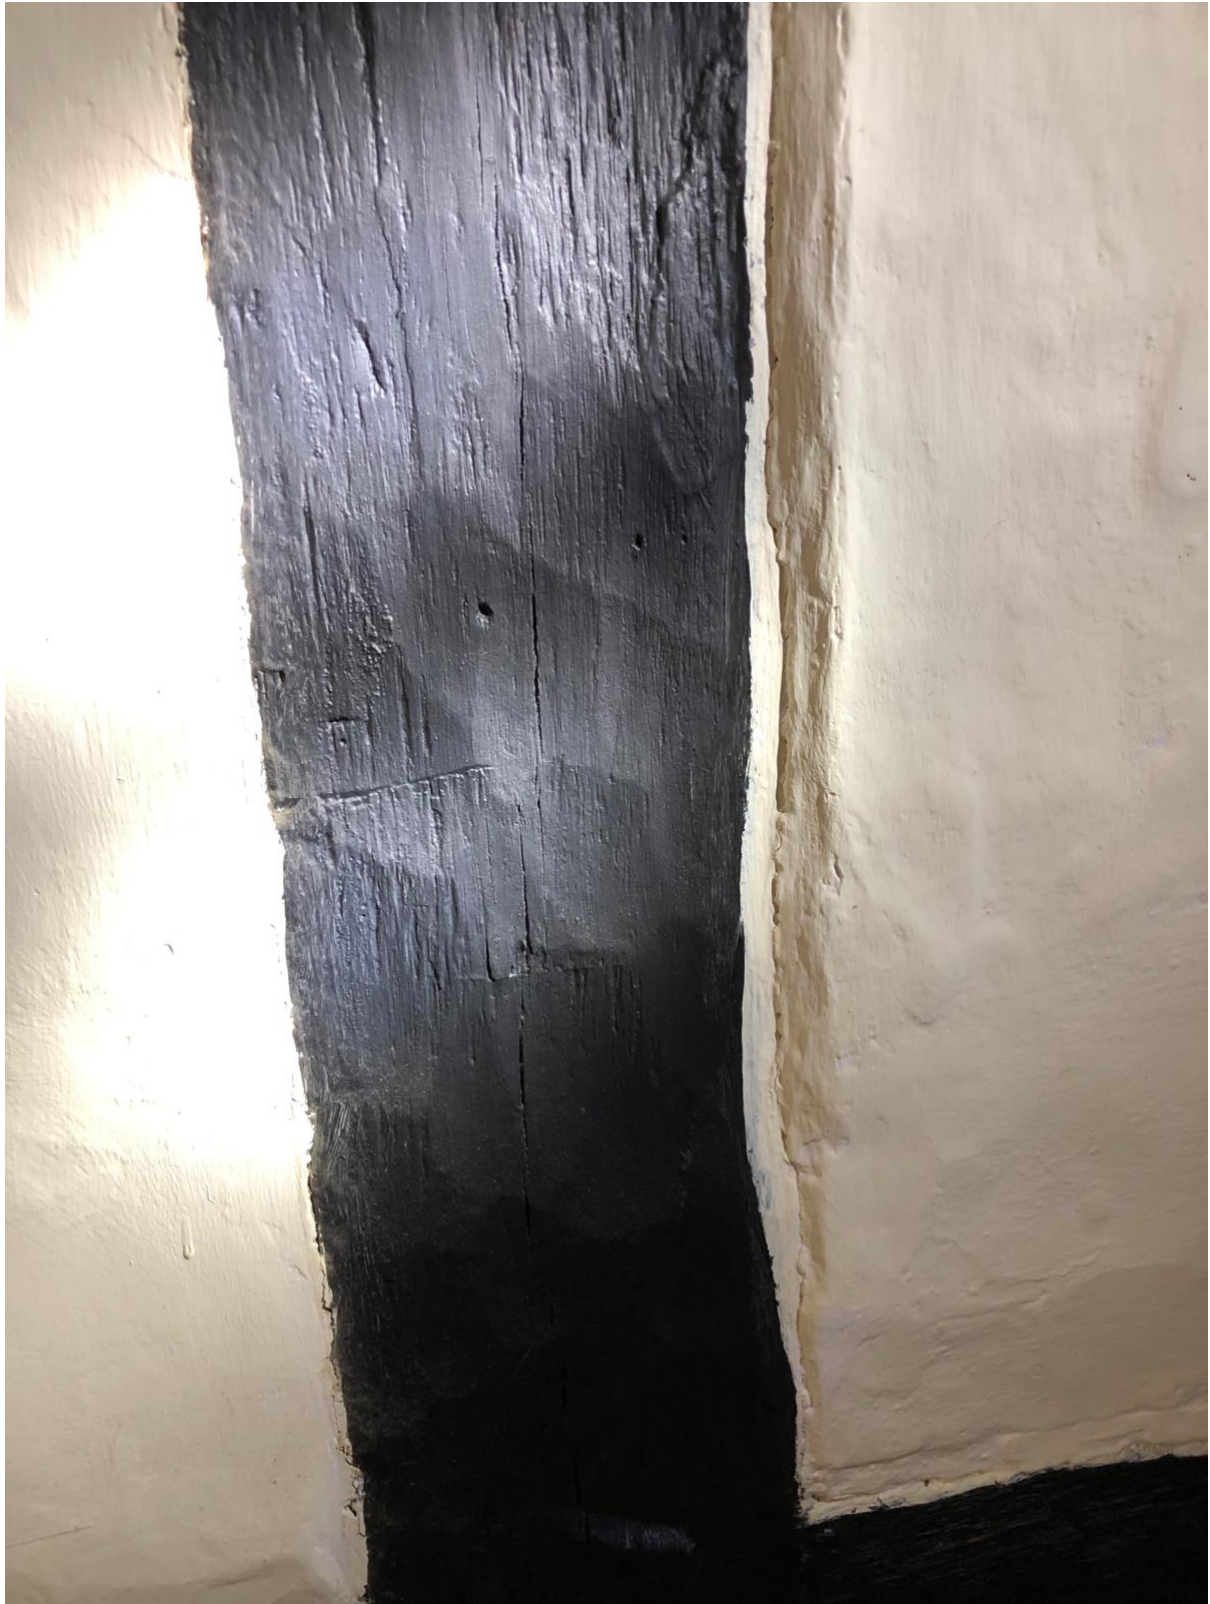
Figure 12, this timber shows evidence of the use of a 'Adze' a shipwrights tool.

This timber shows shallow depressions or a wave like pattern, indicative of a shipwright's tool known as an adze. This tool is commonly thought to be used by carpenters working on buildings but in fact it is rarely seen in vernacular buildings.

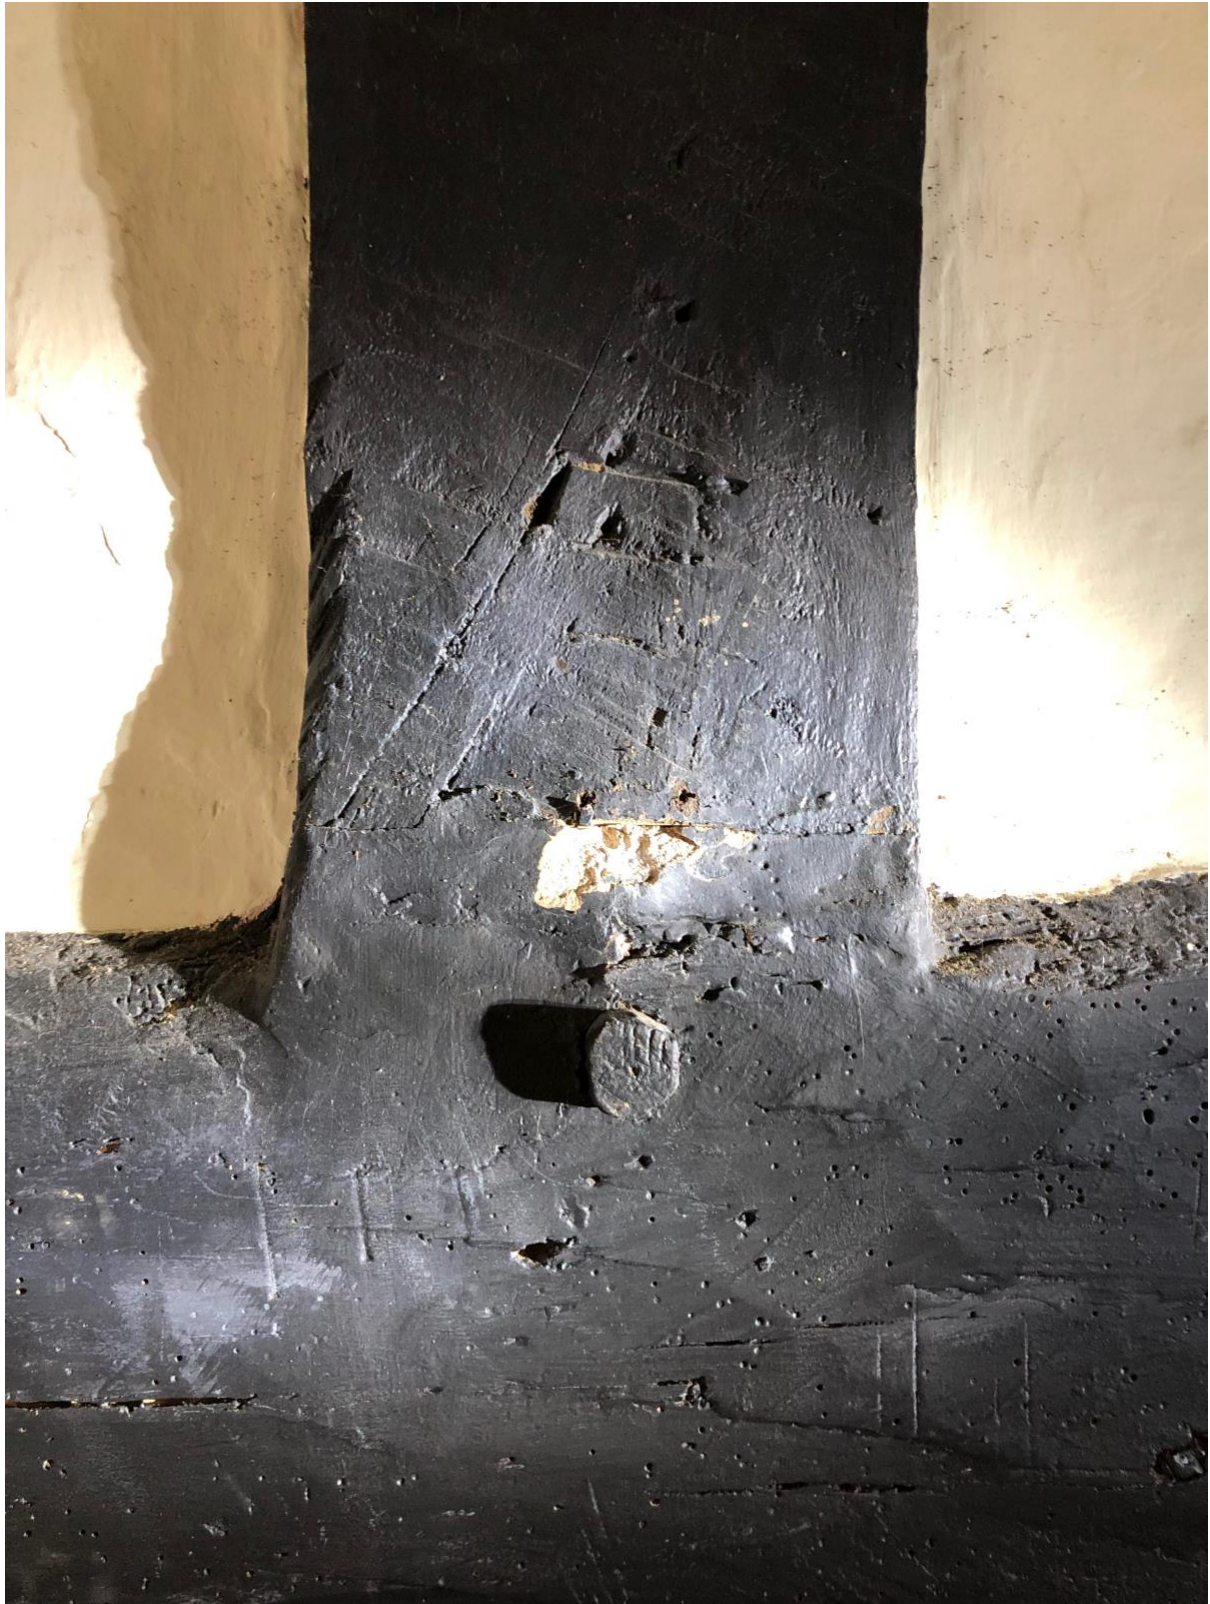
Figure 13, Carpenters assembly marks, in this case II.

These marks made by the carpenters, are created because the 3D frame is created in smaller 2D frames in a framing yard. Each component is individual and fits perfectly to its mating timber. It is then disassembled and moved to the site for erection. The numbers inform the carpenter of the correct connecting timbers in the final assembly.

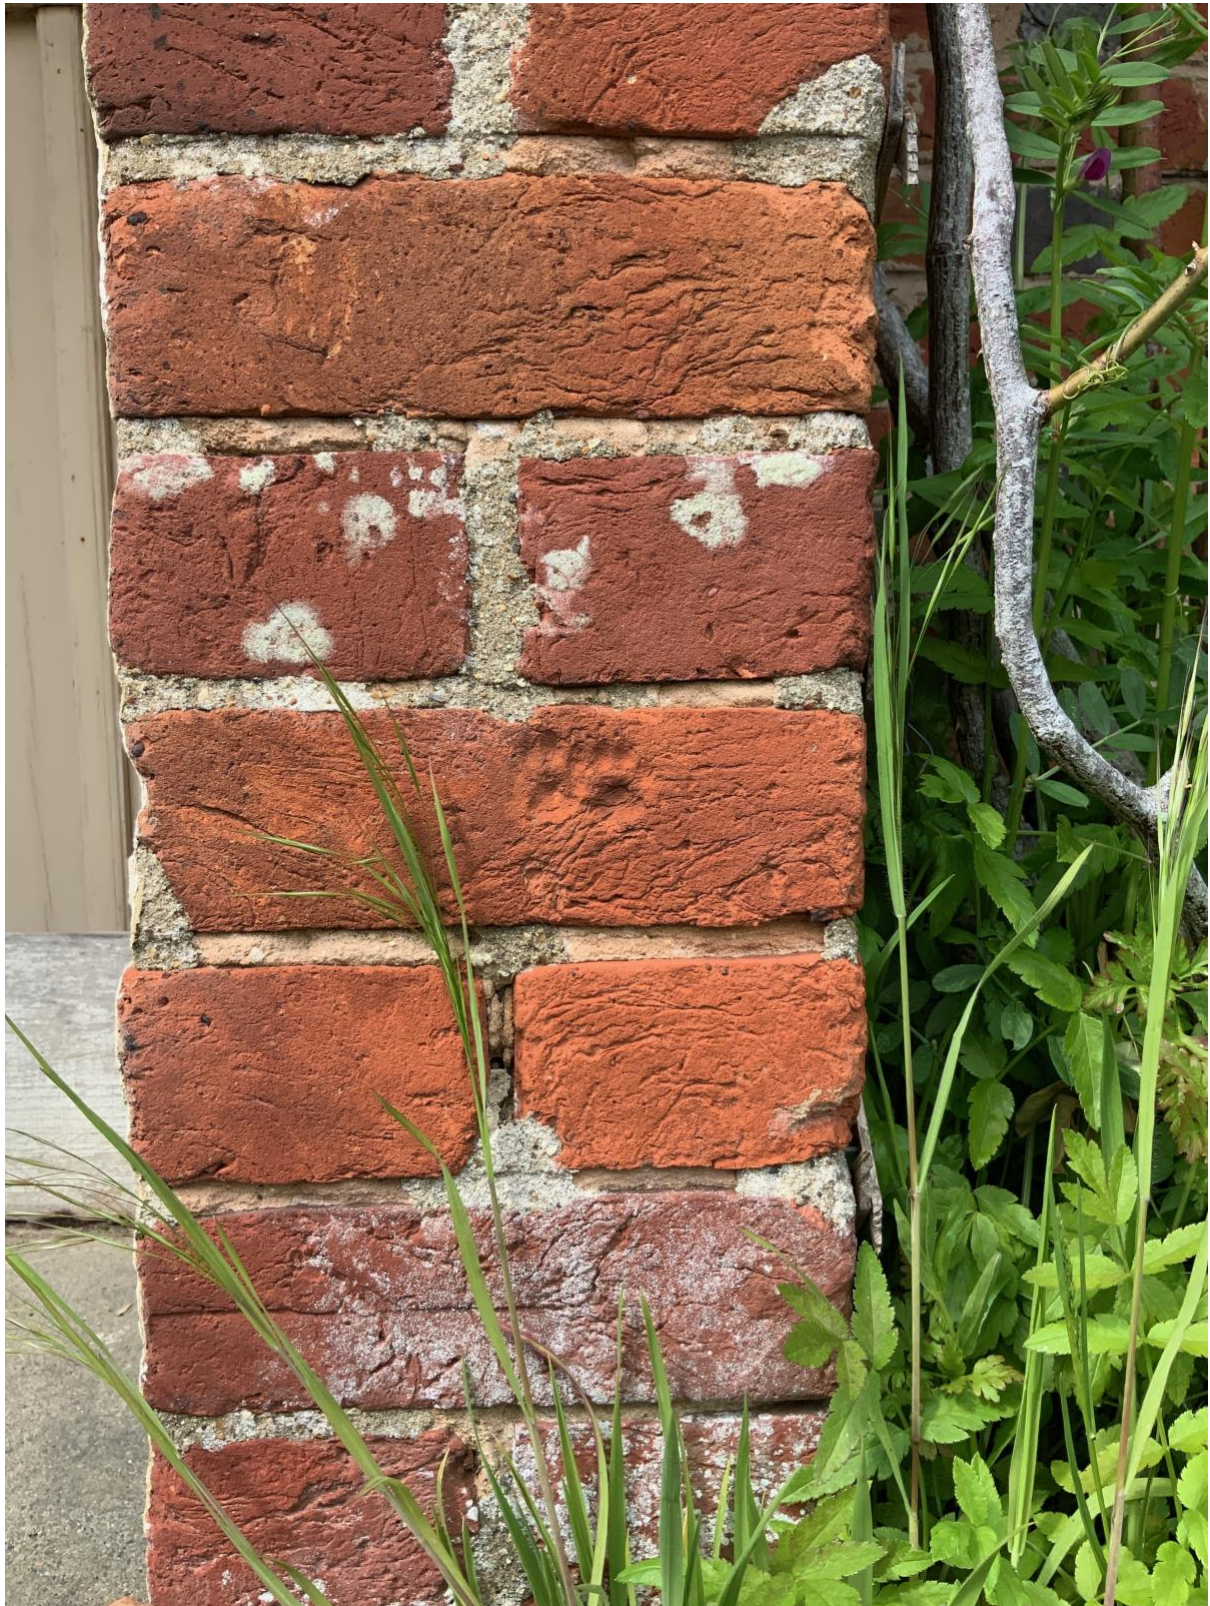
Figure 14, Cat's paw prints in the bricks.
