Historic Significance Assessment

Lughurst Burdocks
Fittleworth Road
Wisborough Green
West Sussex
RH14 0EU

Roland Locke MSc
Historic Building Conservation and Repair Ltd

20th June 2019

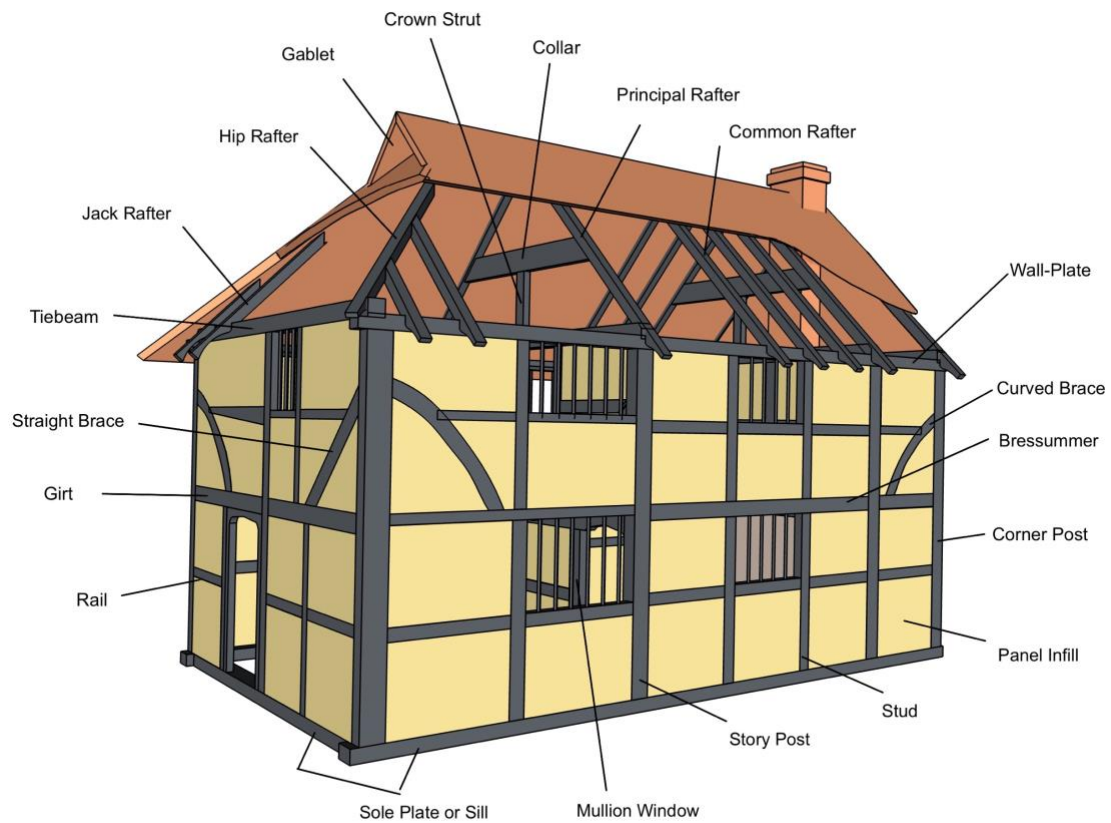
Figure 3, Glossary of components.

The drawing above gives the names of components and their location within the elevation, frame and building.

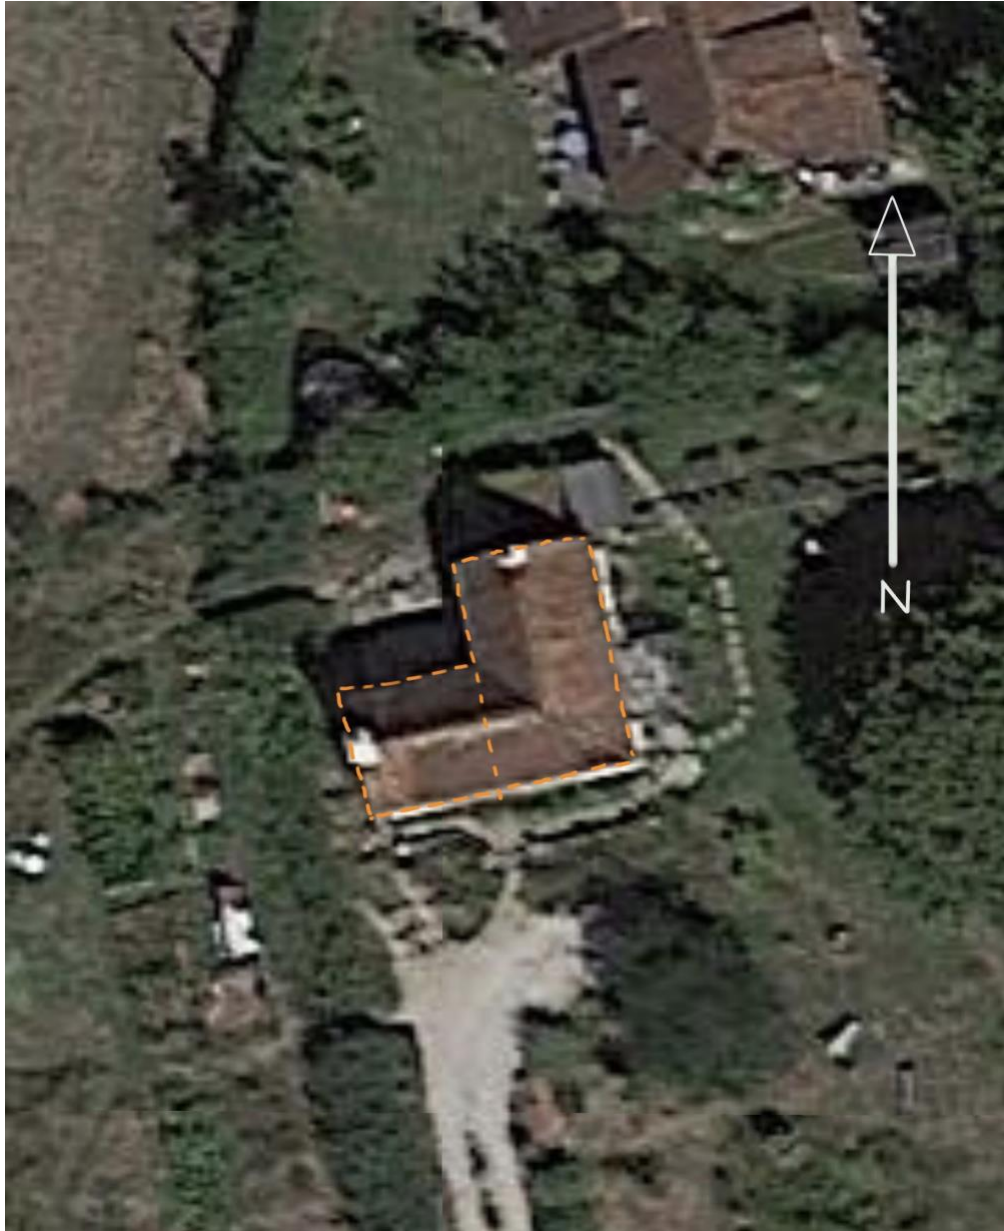
Lughurst Burdocks is an 'L' shaped plan dwelling, situated approximately 80 metres from the Fittleworth Road. It appears to consist of a main range and added wing. The main range aligns North / South and the wing aligns East / West.

Figure 4, Ariel image with outline of Lughurst Burdocks (Google 2019).

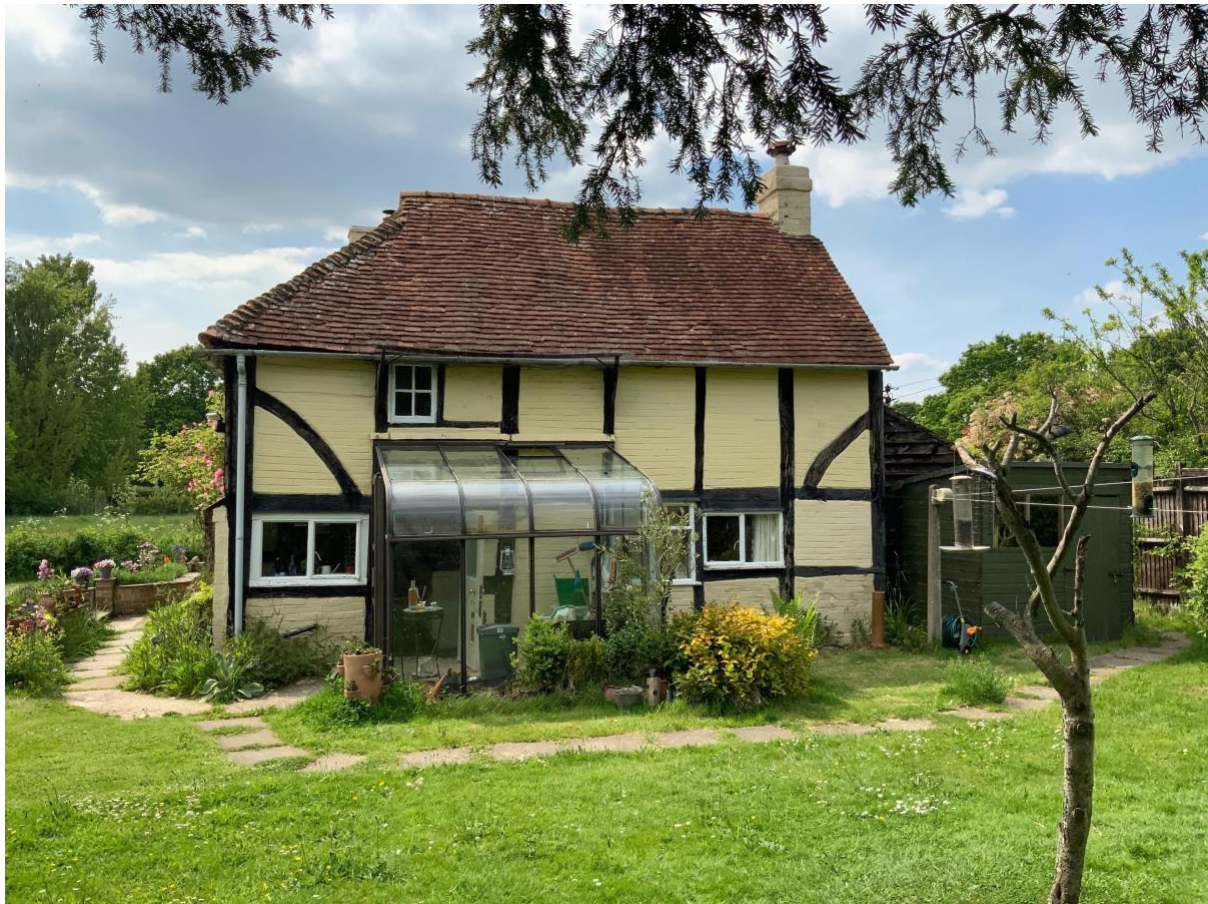
There are 2 full bays plus a short bay containing the chimney.

The roof terminates in the South with a full hip and gablet and is gabled at the North.

Figure 5, East Elevation of main range (Author 2019).

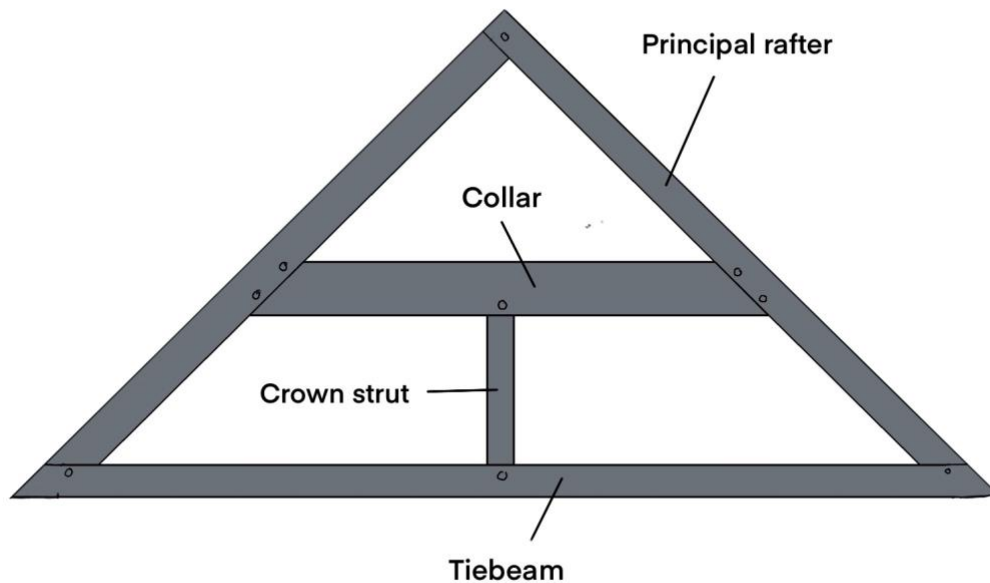
The roof construction for the main range is a 'clasped side purlin' with a 'Crown strut' rising up from the 'tie beam' in 'normal assembly' and set in 'AD Quadratum' or 'common pitch' at 45 degree. The uniform parallel sided principal rafters are collared and connect to the 'tiebeam' at their base in a mortise and tenon joint and join in a 'bridle' at the apex.

The common rafters are not collard and are of light scantling, being on average 3 x 4" (75 x 100mm) and spaced at an average of 20" (500mm). The roof covering is of clay peg tiles on 25 x 20mm softwood batten with iron pegs, there is no felt or breather membrane. There is no evidence of wind braces. The crown strut is an unusual feature as more commonly queen or raking queen struts are found. The principal rafters are not notched over the purlin.

Figure 6, Roof truss arrangement. (Roland Locke 2019).

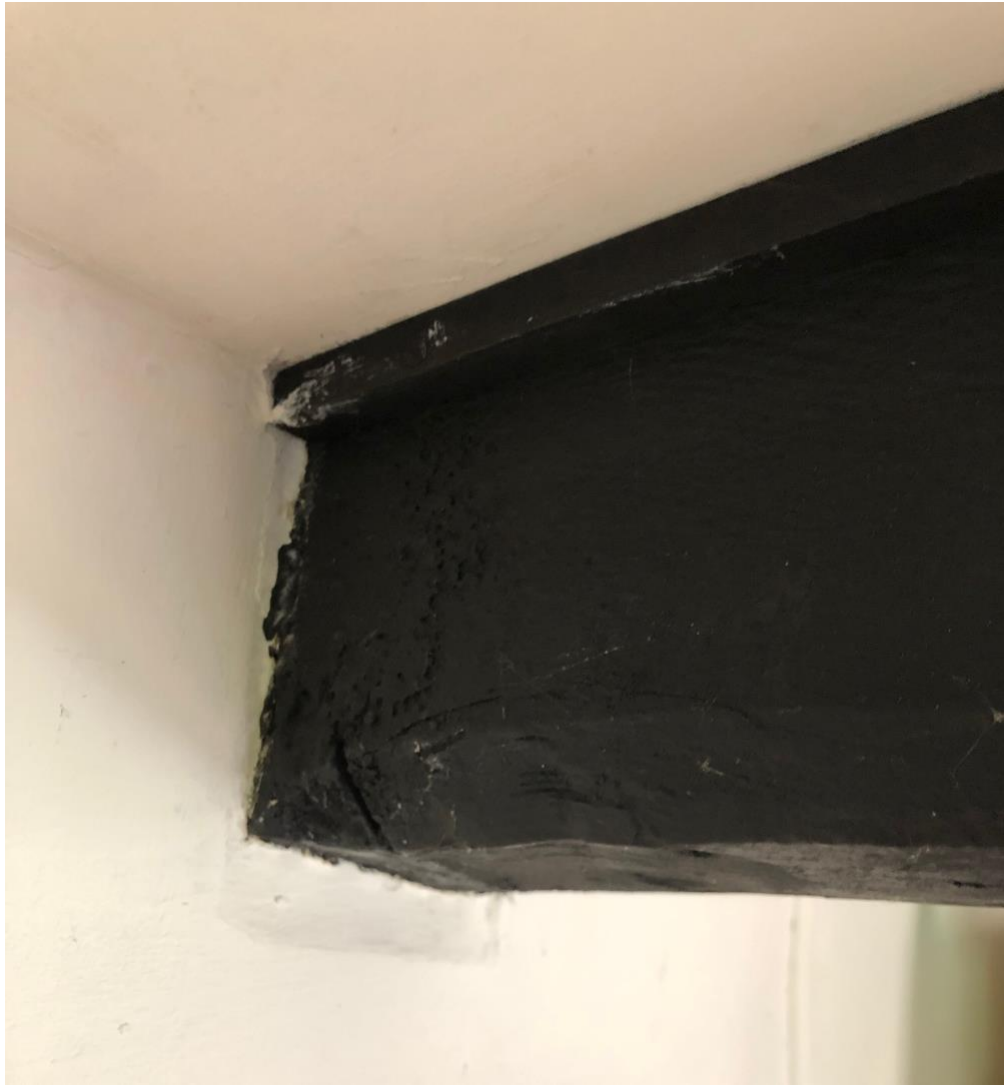
On the first floor there are plaster-boarded ceilings which have been fixed to the soffit of the collar and additional later softwood joists. On the ground floor, thin painted boards have been fixed between the 4" (100mm) square joists with step curved chamfer stops.

Figure 9, Joist end showing chamfer stop. (Author 2019).

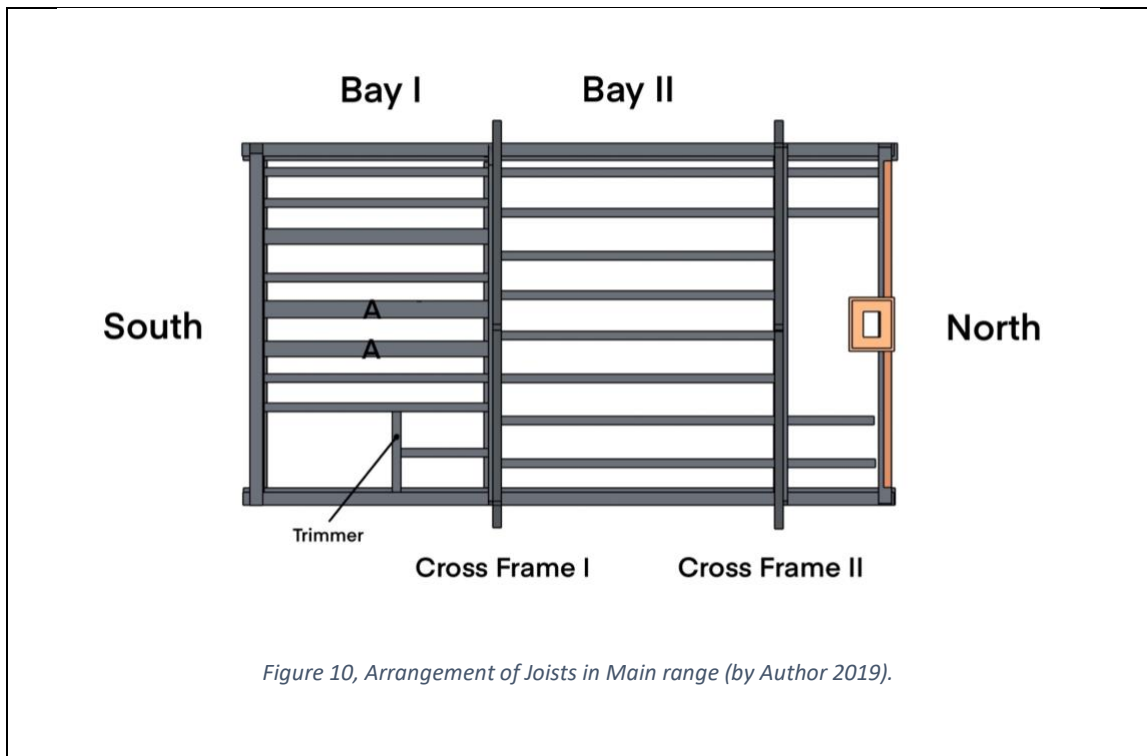
Within the present kitchen there are at least 2 joists of medieval section i.e. are large section and laid flatwise (marked 'A' in Figure 10 below). The North end of all joists within this bay are 'lodged' over cross-wall I 'Girt' but are tenoned into the 'Girt' in the South elevation. There is no evidence of mortises large enough to accommodate more joists of medieval section size.

Figure 10, Arrangement of Joists in Main range (by Author 2019).

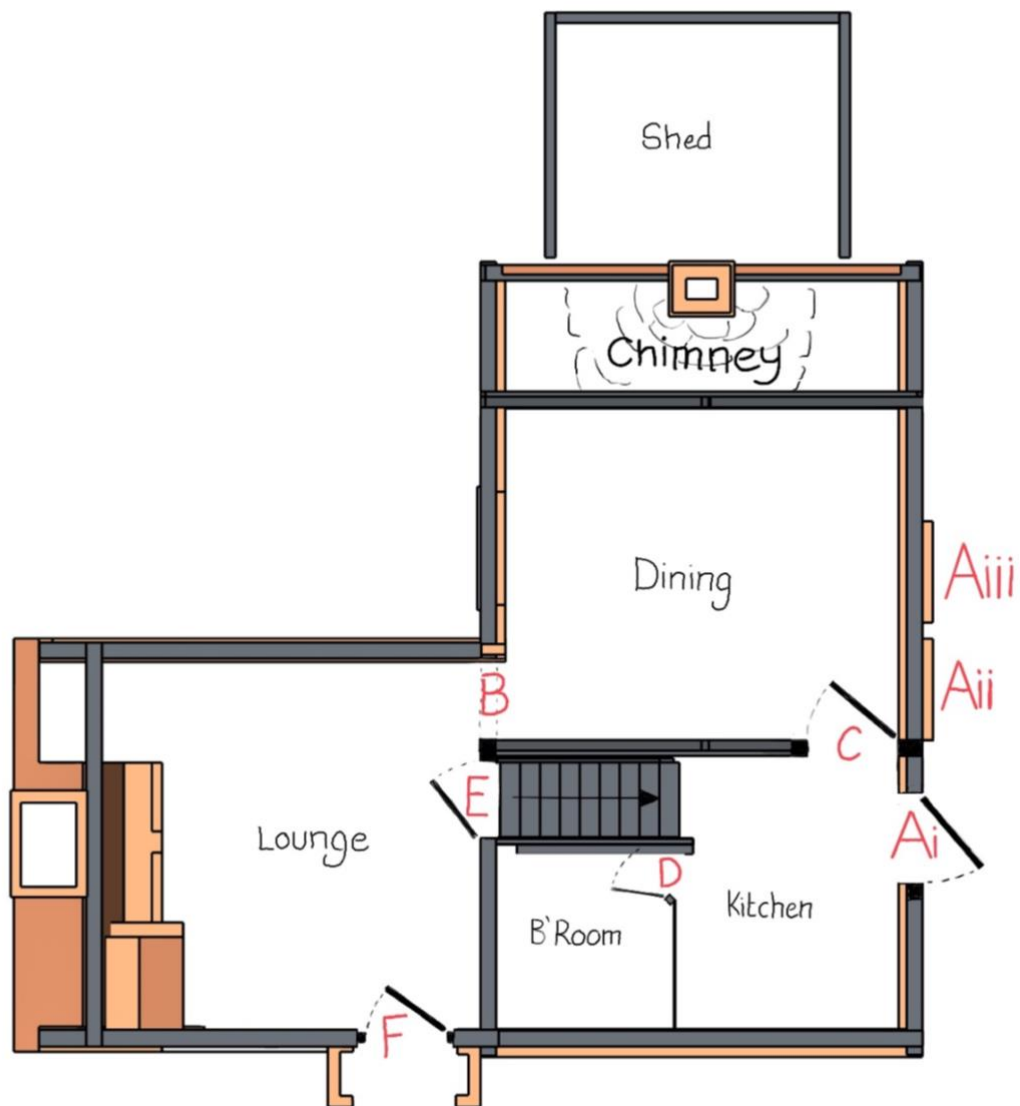
Figure 11, Plan showing position of doors. (By Author 2019).

The extant exterior doorway [A] containing a part glazed Victorian door lies towards the South end of the East elevation, where a rail has been truncated to accommodate. However, there is evidence that two more previous positions may have existed, [Aii & Aiii in the image above], as it would appear that mid rails once existed in these panels, the presence of correspondingly placed pegs in the studs could confirm that a rail once existed, which if no longer present may indicate that a doorway or window had been created in that location. In position [Aii] pegs do exist in the studs and we can be reasonably certain that the rail was removed. At [Aiii] the enlarged window has removed the portion of timber that would have housed the pegs. At position [Aii] and [Aiii] there exists a step in the brick plinth which may have been made in connection with a doorway. However, the author cannot see

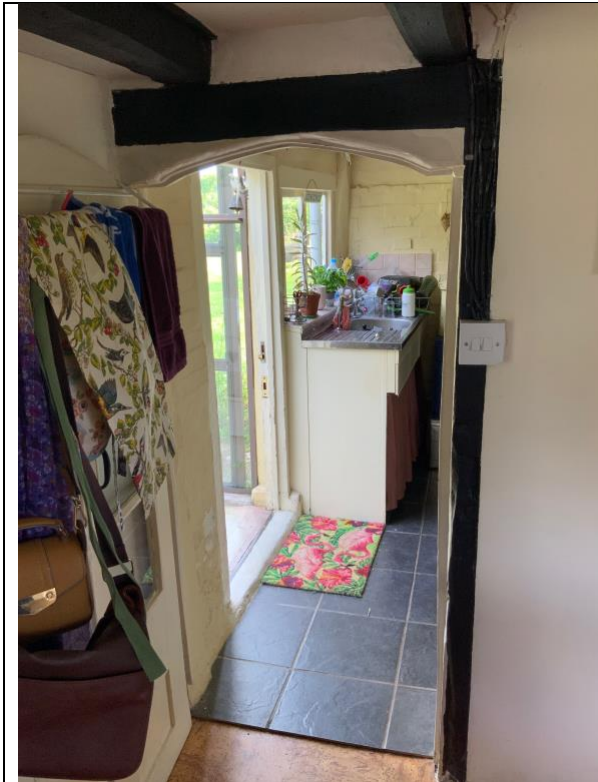
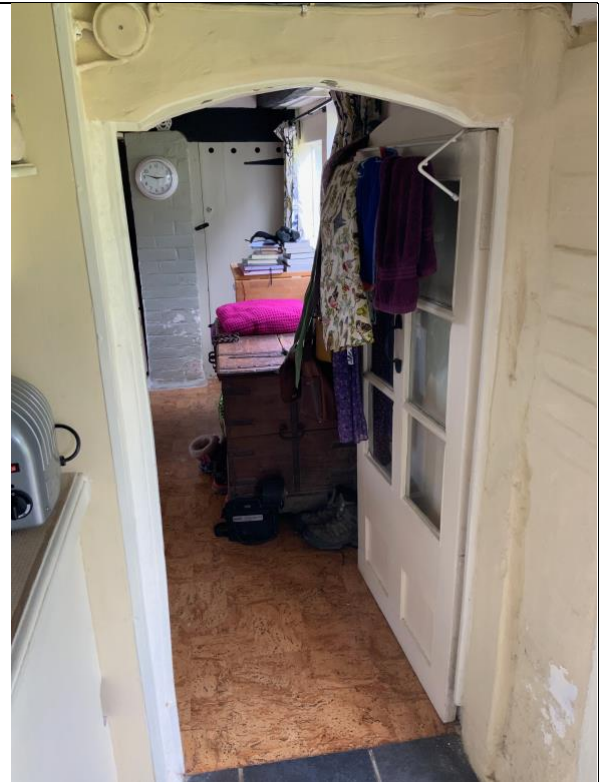
The East post consists of the main 'Story Post' set in the East elevation, the West is a stud set between the girt and the floor in Crossframe I. The 4 centred door head is cut out of the soffit of the 'Girt' and is moulded on both sides. The door set within this aperture is a painted modern $\frac{3}{4}$ glazed softwood door. It appears as though there may have once have been an additional post on either side, which may have also been moulded. As there is little evidence of pintles or latch housings from previous door arrangements and the moulded head finishes abruptly.

Figure 13, Doorway [C] From North (by Author 2019).

Figure 14, Doorway [C] from South (by Author 2019).

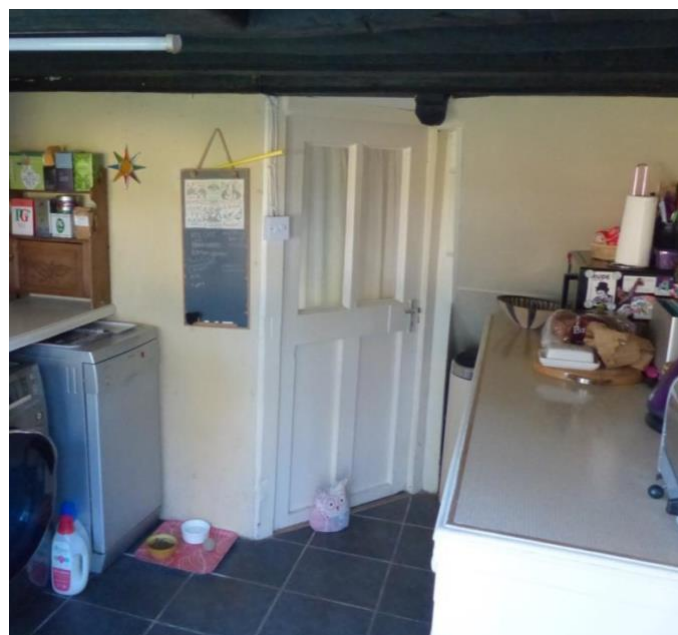
This door has been created in a relatively modern single skin partition wall formed to create the space for the bathroom within the kitchen area. The door appears to be a reduced height half glazed Victorian door.

Figure 15, Bathroom door. (Dave Green 2019).

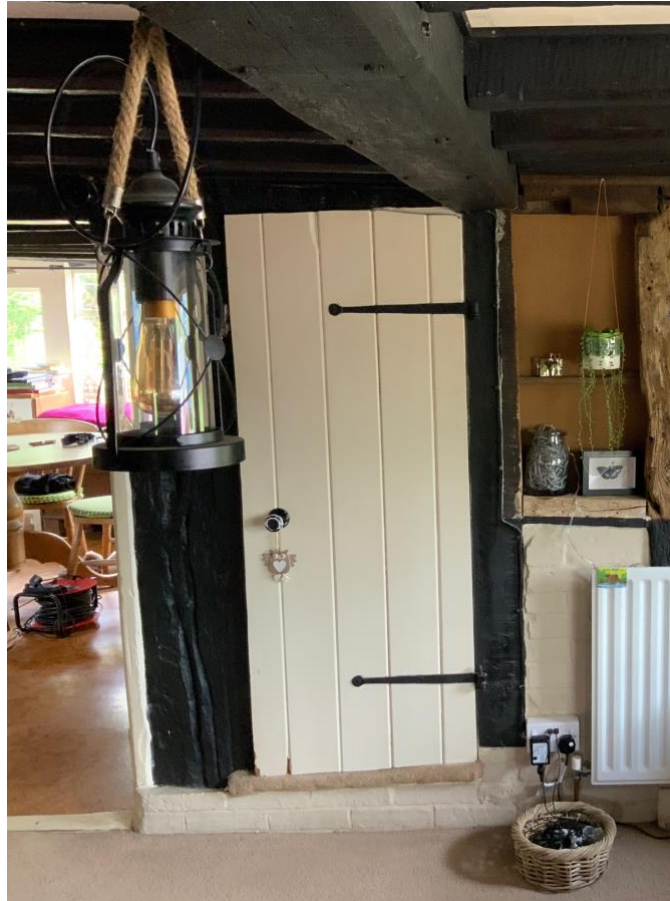
This doorway leads to the base of the current stairs which appears to have been formed in the West exterior wall of the main range. All adjacent timbers that might have contained evidence of previous walling have either been removed or are covered by later fabric. The door is planked, and the strap hinges are fine examples of hand forged wrought iron.

Figure 16, Door to base of stairs from Lounge. (author 2019).

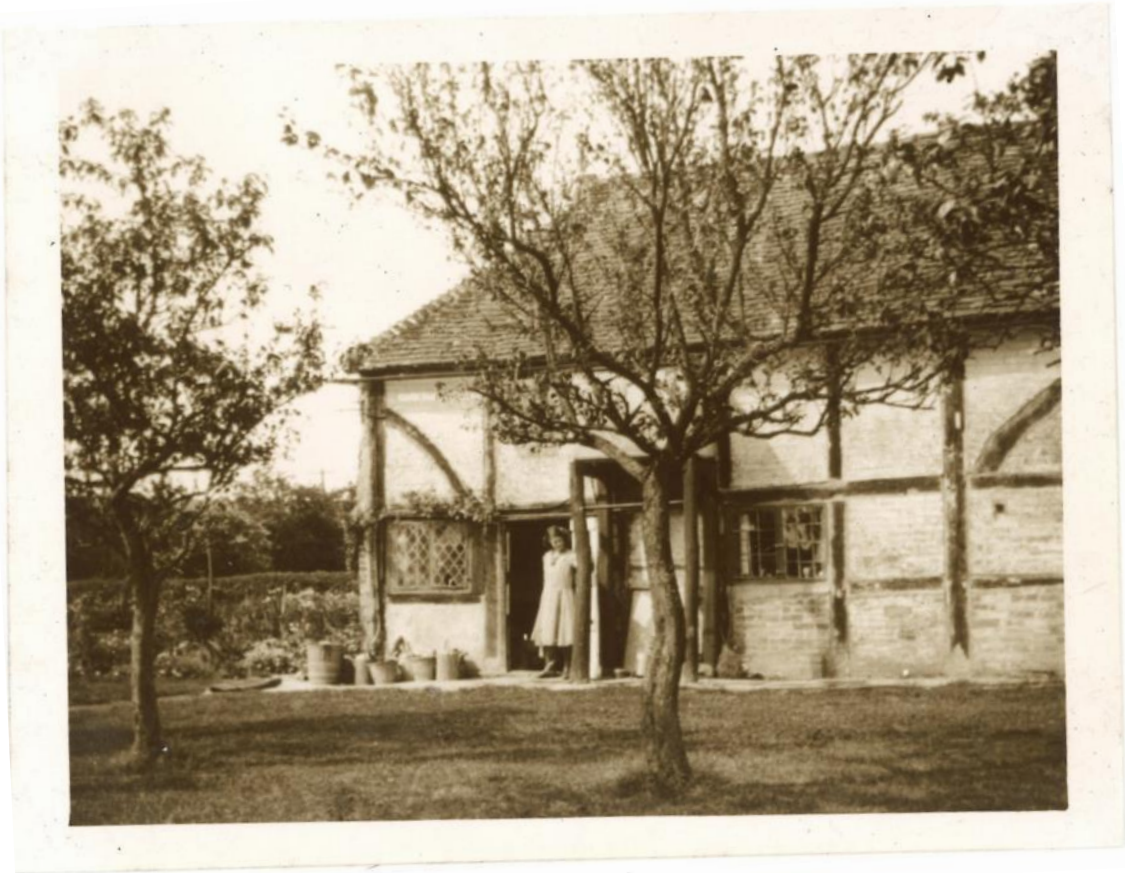
However, an additional window aperture has been made in the main range East elevation at ground floor level, since the 1937 photos.

Figure 17, East Elevation of main range from 1937.

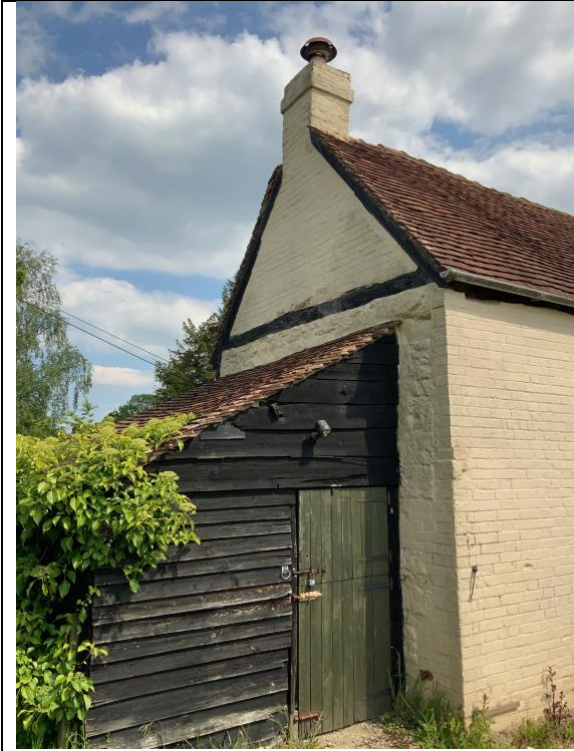
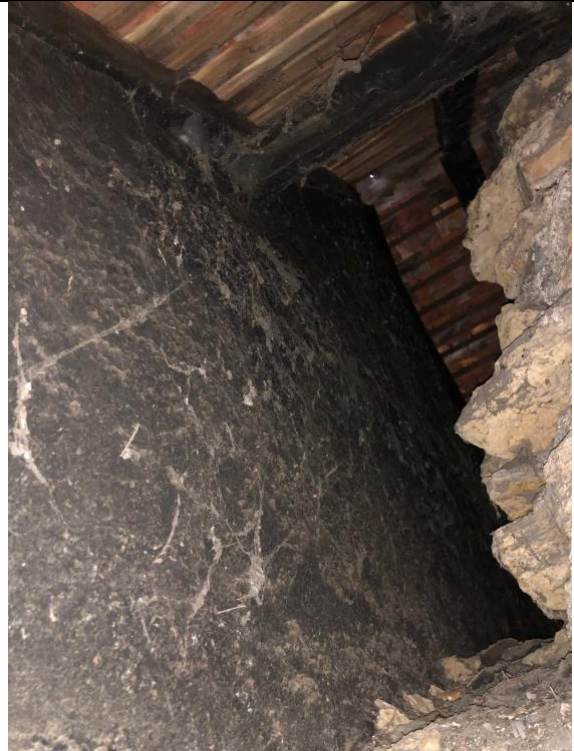
As previously described the exterior wall (North) is currently made of random laid stone, set in lime. Which when viewed from the exterior is brick above the 'Tiebeam'. However internally, above the tie-beam it is stone (see Figure 20 and Figure 21, below). However, it can be seen that the inside face of the walls and the rafters within this bay are heavily sooted. Additionally, the lime plaster extends across the faces of the timber frame.

Figure 20, North gable end. (Author 2019)

Figure 21, Inside wall of chimney bay (Author 2019).

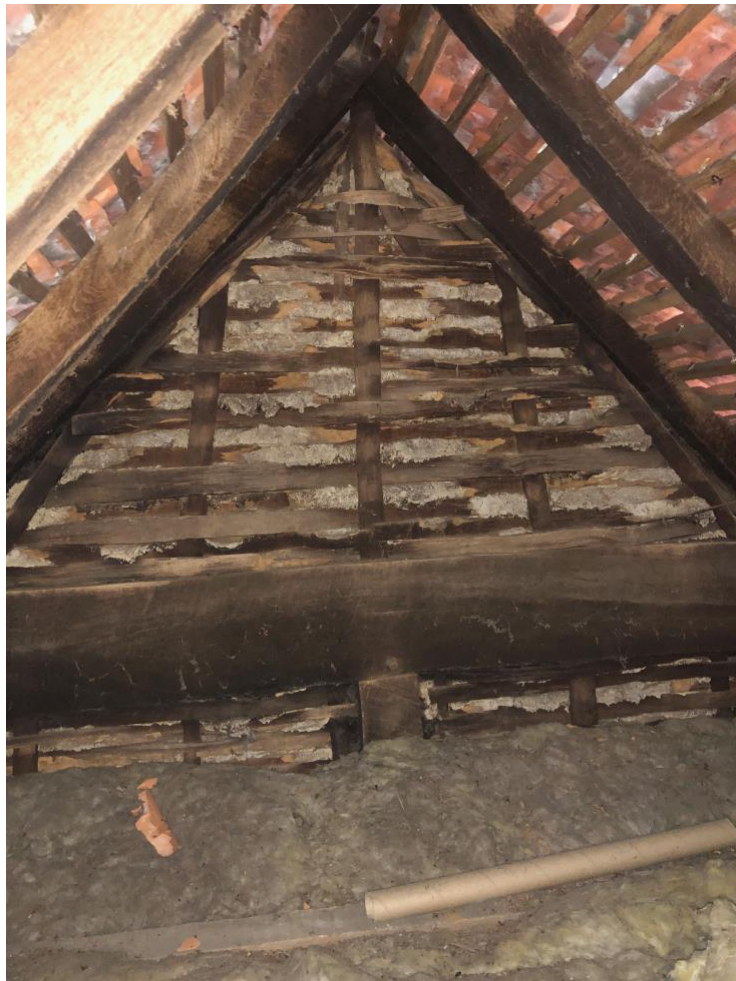
Figure 22, View of cross-frame II from inside the neighbouring bay roof space. (Author 2019)

It is clear that a great deal of smoke was present in the chimney bay. There is evidence of smoke coming through gaps in the daub and depositing soot on nearby fabrics (see Figure 22). However, there is no evidence of smoke on the underside of the tiles or the outside of stone chimney flue that lies within the chimney bay. (see plan below – smoke deposited areas are marked in red).

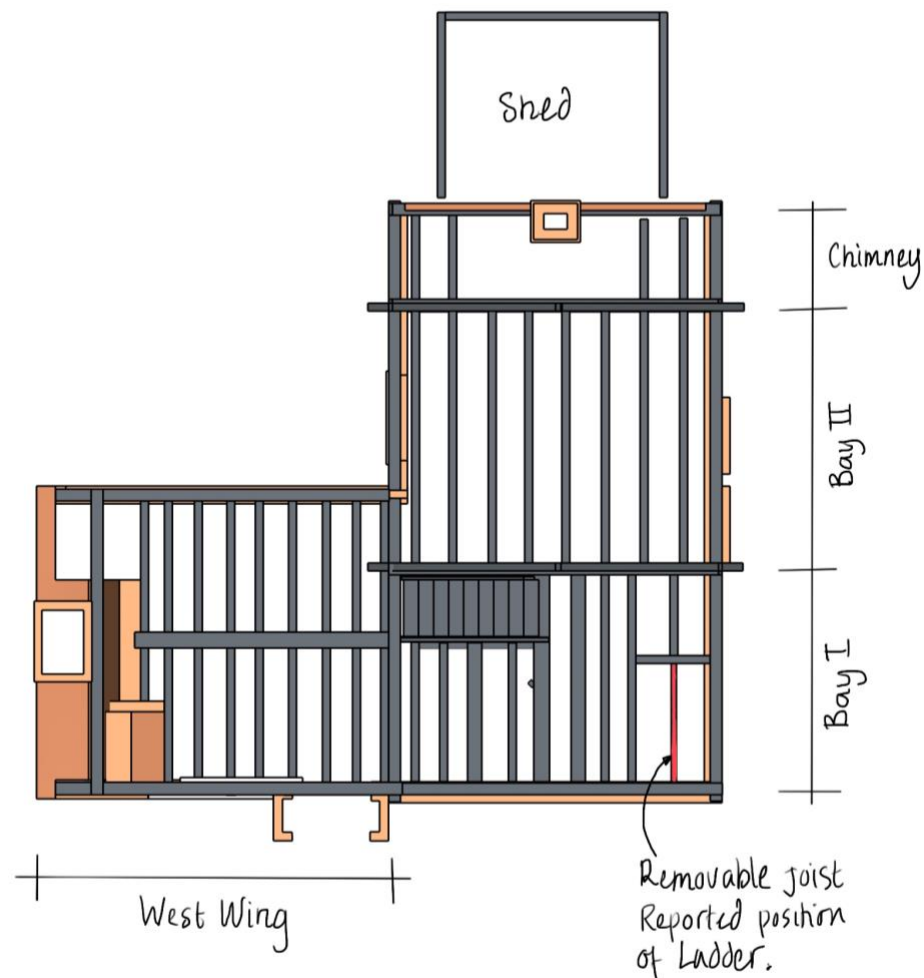
The stairs run from the West to East within the main range and are perpendicular to the direction of the joists in bay I and set at a 45 degrees pitch. There are 11 steps of 220mm of rise and going. The base of the stairs can be found within the West wing, where there is a door that opens out into the West wing marked [E] in doors description above. The current owner informs the author of this report that the previous owner had had these stairs installed. As within his ownership a ladder existed in the South East corner of bay I. At the location reported, there is a much smaller joist set between a trimmer and the girt in the South elevation. This joist appears to have been so devised, that it can be removed by lifting upwards and out of a 'U' shaped piece of timber (see Figure 23 and Figure 24).

Figure 23, Floor Plan showing arrangement of floor joists.

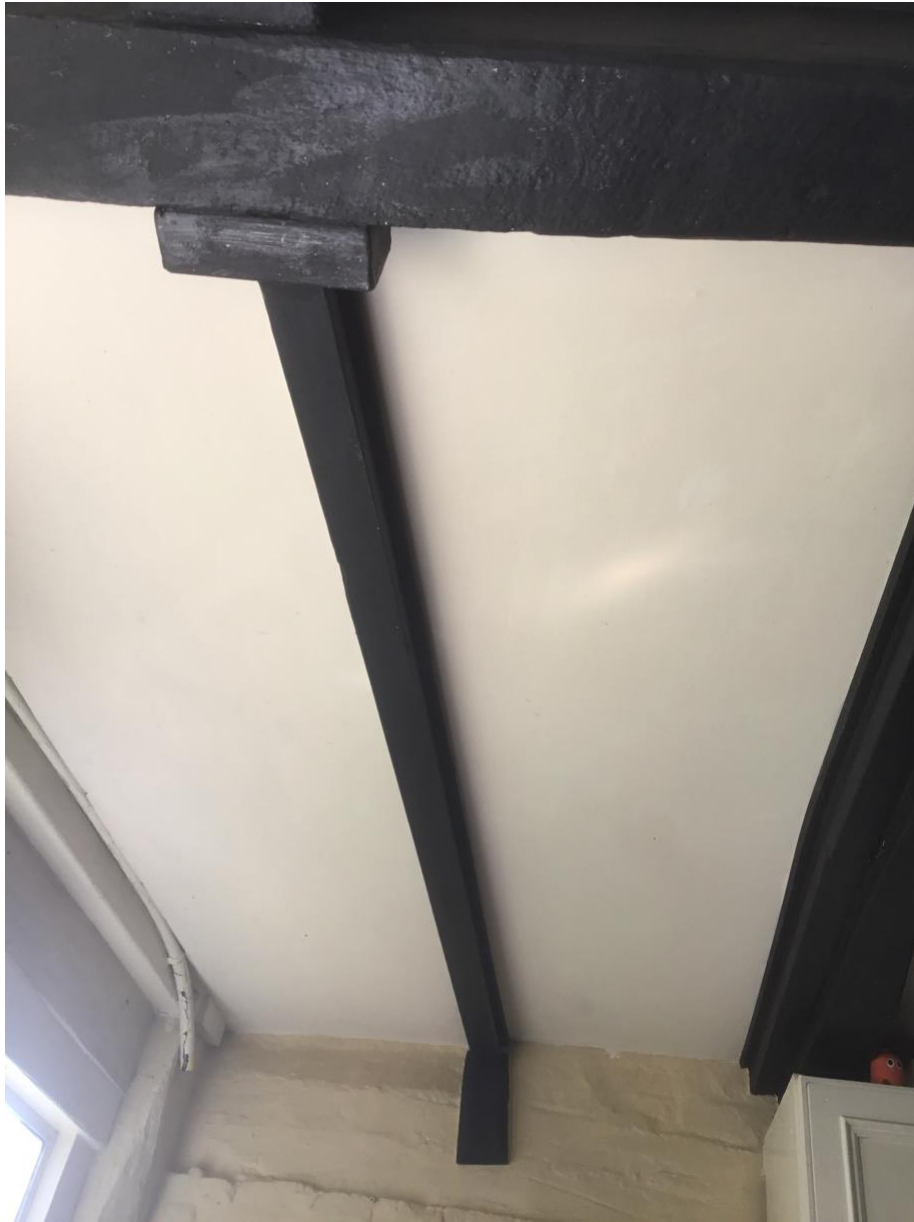
Figure 24, Removable Joist found in South East corner of Bay I (Deborah Woollin 2019).
